Fault Code: 2155

Post-Oil Filter Pressure Sensor Circuit - Voltage Below Normal or Shorted to Low Source

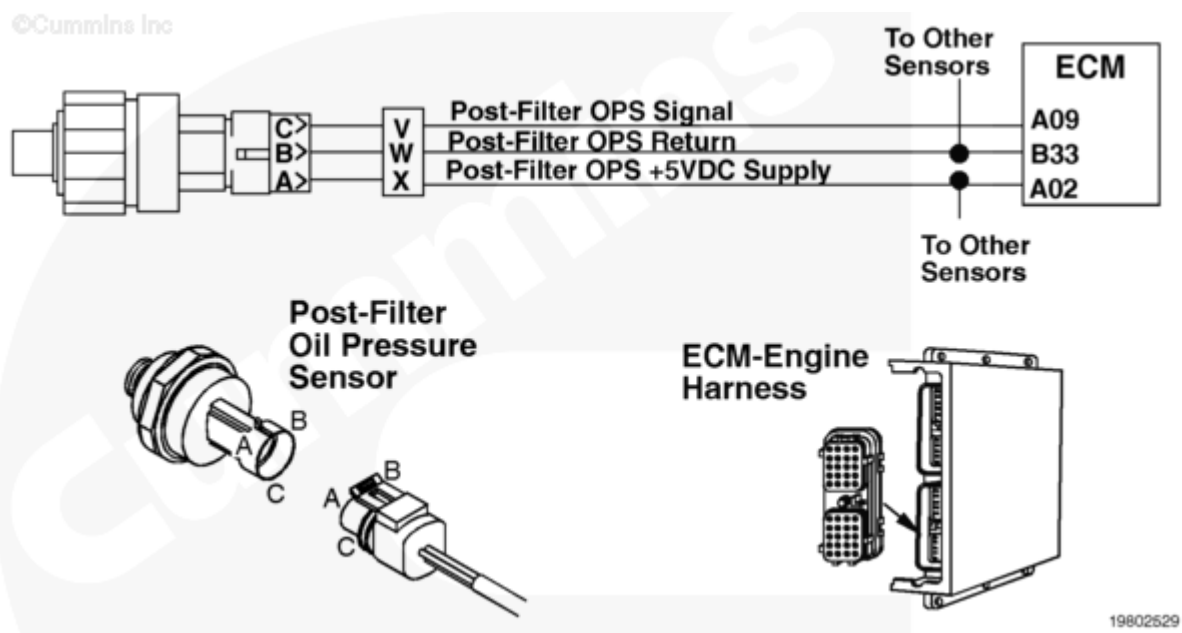
Post-Filter Oil Pressure Sensor Circuit

Codes	Reason	Effect
Fault Code: 2155 PID(P): 100 SPN: 611 FMI: 4 Lamp: None SRT: 00-686	Post-Oil Filter Pressure Sensor Circuit - Voltage Below Normal or Shorted to Low Source. Low voltage detected on SIGNAL pin 09 of the main harness A ECM connector.	Fault Code 612 is disabled.

The post-filter oil pressure is the engine oil pressure after the oil has passed through the oil filters. The post-filter oil pressure sensor sends the post-filter oil pressure signal to the CENSE™ ECM.

The post-filter oil pressure sensor is located on the oil outlet side of the lubricating oil system filter head.

- If the fault occurs **only** in a cold environment, allow the oil to warm up and see if the fault becomes inactive.
