Technical Service Bulletin: TSB140063

Cylinder Head Gasket Exhaust Side Coolant Orifices Misaligned with Cylinder Block Passages

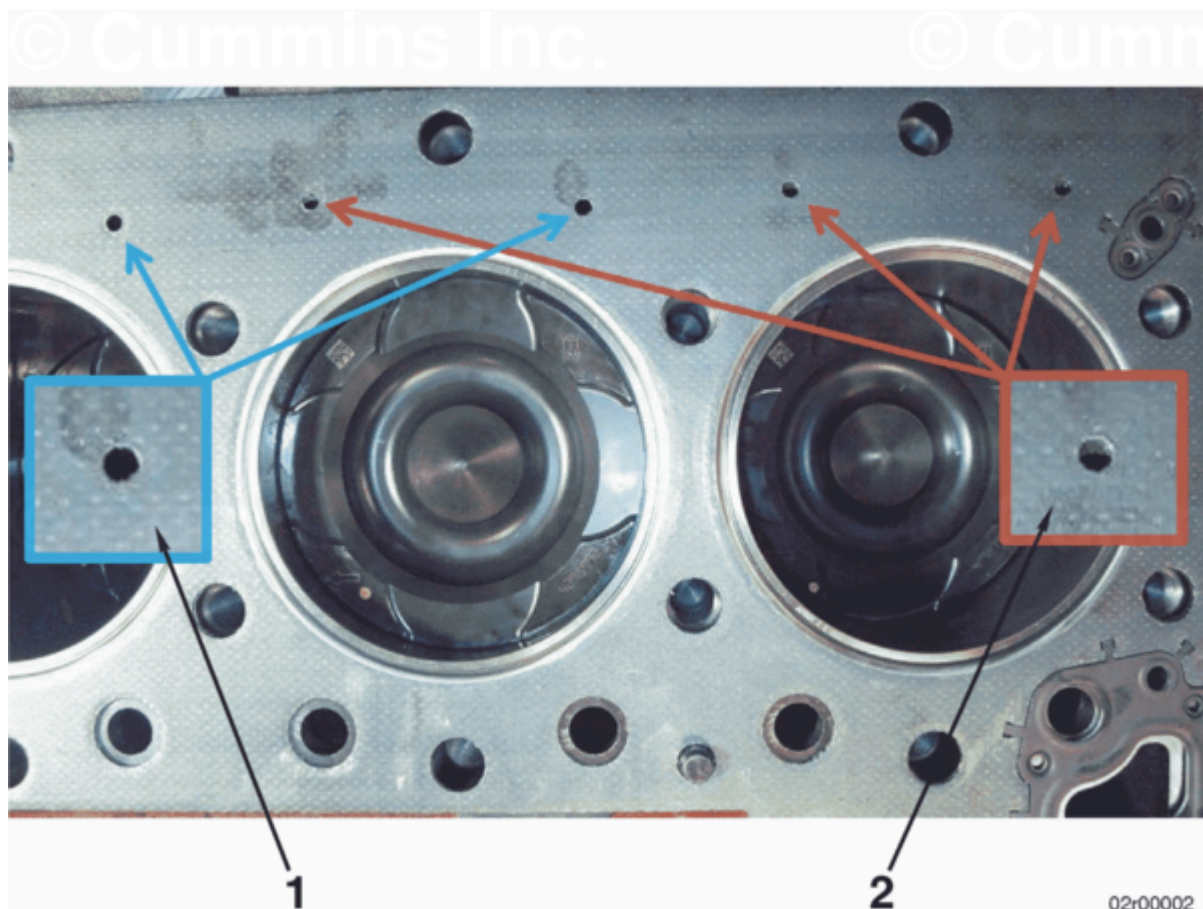
Figure 1, New Cylinder Head Gasket on Cylinder Block

Heavy duty cylinder head gaskets with Part Number 4299098 have 12 orifices on the exhaust side of the engine that are primarily used for venting the cooling system. Some gaskets have the potential for three of these orifices to be misaligned with the coolant passages in the cylinder block.

With the cylinder head gasket located on the cylinder block, misaligned orifices will be identifiable near cylinders 5 and 6 (reference Figure 1).

1. Regular Orifice.
2. Misaligned Orifice.

New cylinder head gaskets identified with misaligned orifices in these locations are fit for service and should be used, **not** scrapped.

Gaskets removed from service are **not** considered failed or defective as a result of misaligned orifices observed in these locations.
