Technical Service Bulletin: TSB140133

Released Date: 28-Oct-2015

New Rear Gear Camshaft Idler Shaft

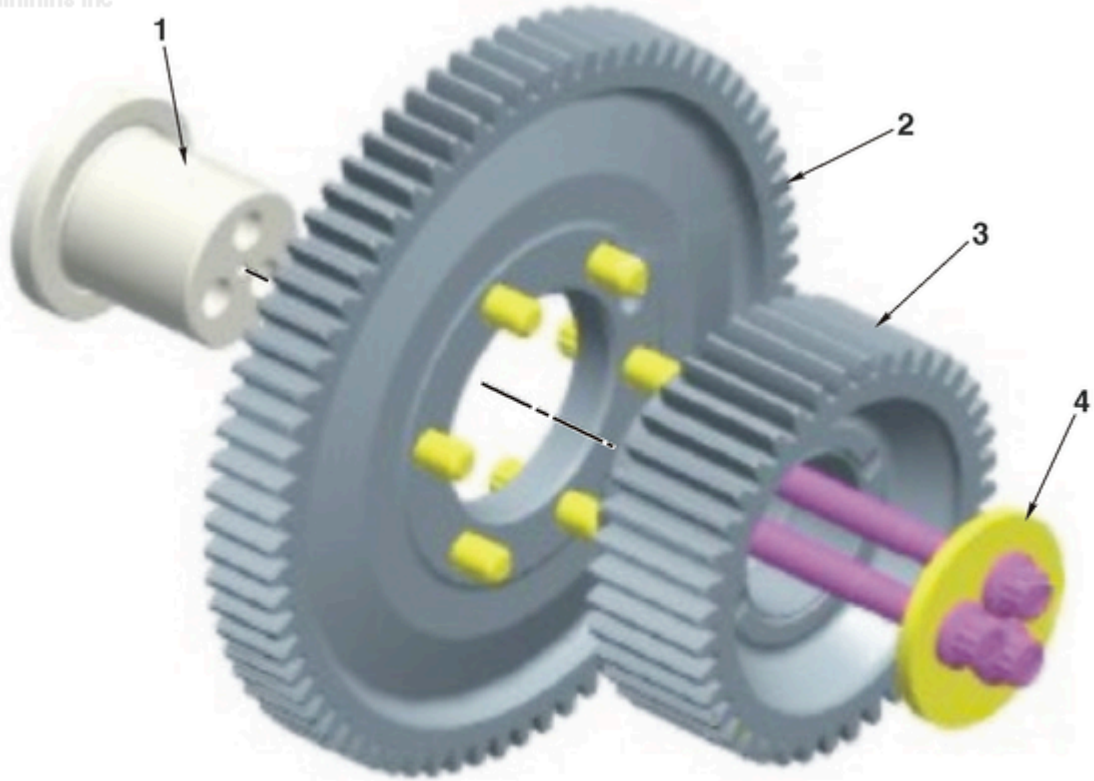
Figure 1, Obsolete Design

1. Camshaft idler shaft
2. Idler gear (large)
3. Idler gear with bushing
4. Gear retainer

New design includes improved clamp load for rear gear camshaft idler shaft and improved idler gear bushing lubrication.

Obsolete rear gear camshaft idler shaft and idler gear with bushing not compatible with replacement parts. Component oil lubrication will be affected, engine damage will result.

Replacement part numbers recommended for use.

Camshaft idler shaft, idler gear with bushing, and gear retainer part numbers have been obsoleted. When replacing any of these parts, all must be replaced.
