Technical Service Bulletin: TSB200219

Release of Thermal Recirculation Valve with Integrated Check Valve

- X15 CM2350 X114B
- X15 CM2350 X116B

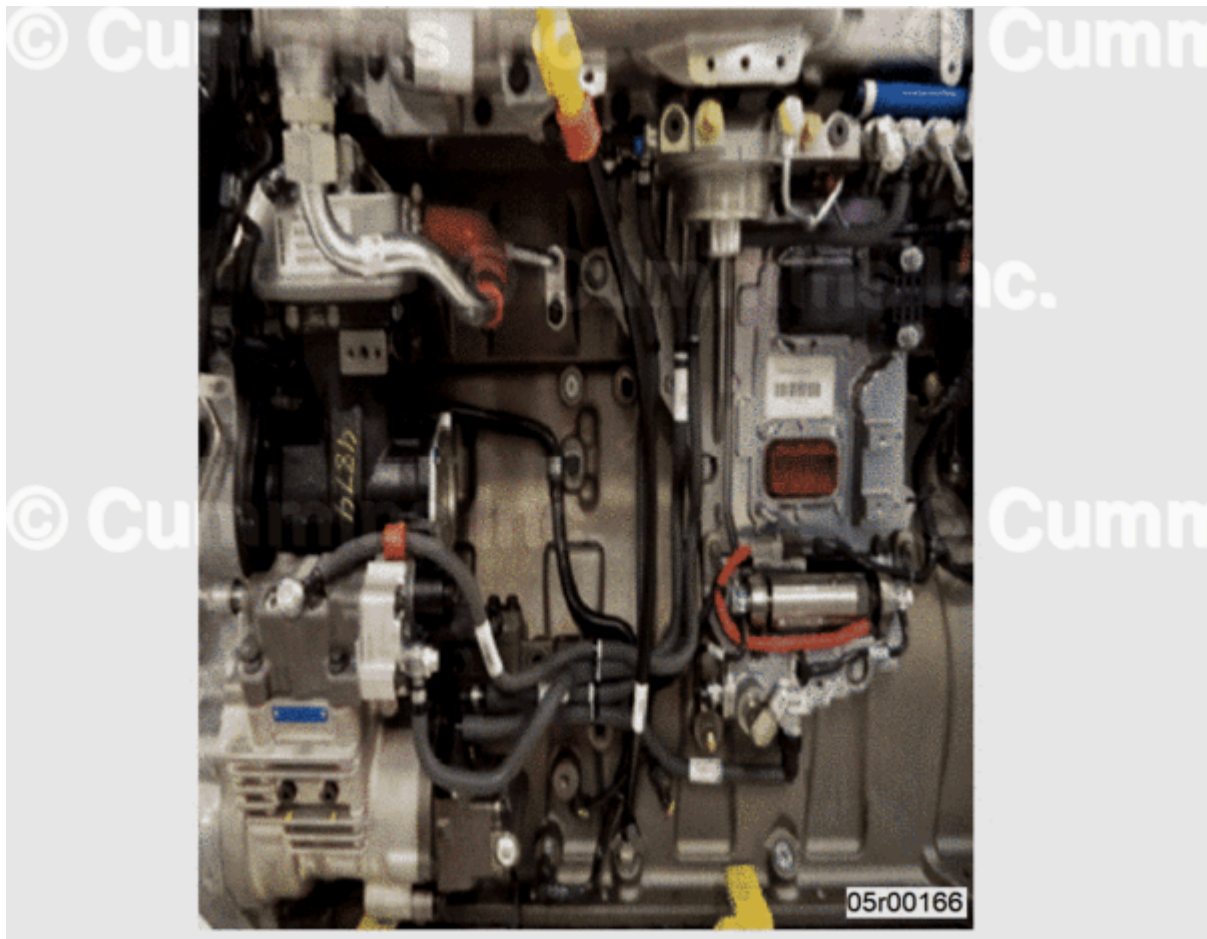
Figure 1, Representation of Configuration A.

Configuration A

Approximate engine serial number (ESN) range for configuration A: 79890940 to 80038419. For ESN outside of this range confirm part numbers from Table 2.

No service kit is available for this configuration.
