Fault Code: 112

Timing Fueling Flow Mismatch

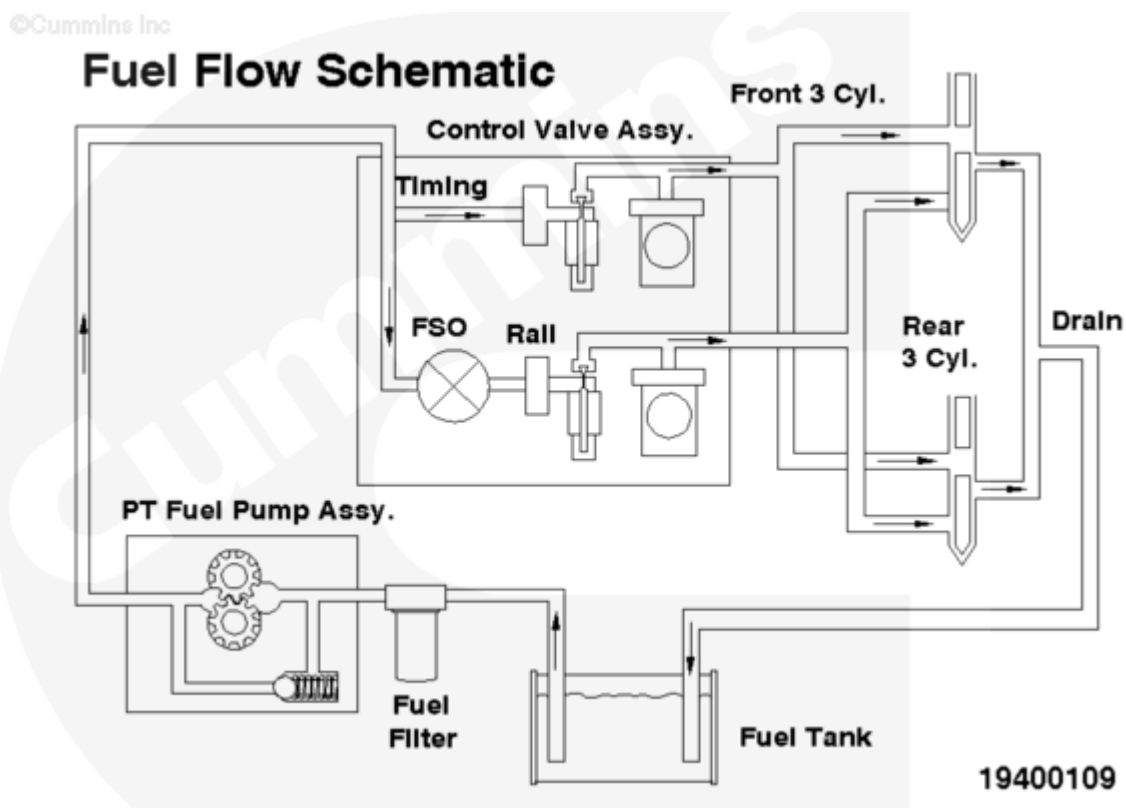
Fuel System Flow Schematic

The electronic control module (ECM) uses the timing pressure signal and engine speed to estimate the actual timing the engine is receiving and then constantly compares this value to the desired timing for the given speed and load. When there is too large an error in these values for too long a time, this fault is logged.
