Fault Code: 153

Intake Manifold Temperature Sensor Circuit

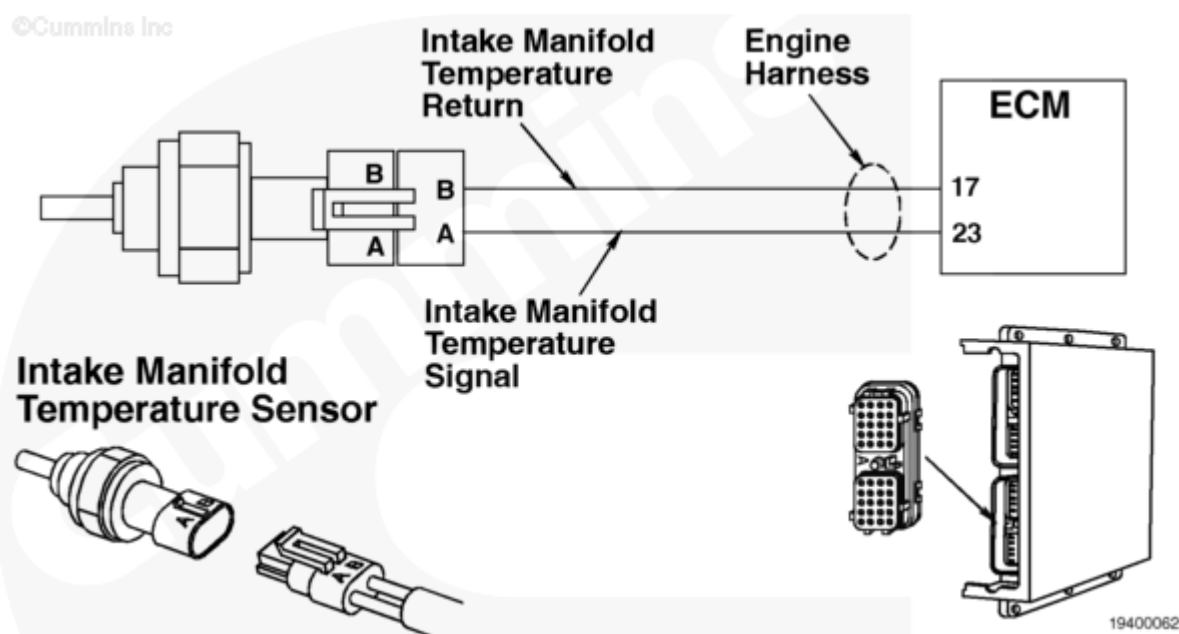
Codes	Reason	Effect
Fault Code: 153 PID(P): P105 SPN: 105 FMI: 3 Lamp: Yellow SRT: 00-358	More than 4.88 VDC detected at the intake manifold temperature sensor signal pin 23 of the engine harness ECM connector.	No engine protection for the intake manifold air temperature.

The intake manifold temperature sensor is used by the ECM to monitor the temperature of the air in the intake manifold after the aftercooler. The intake manifold temperature sensor is used by the ECM for the engine protection system, timing, and fueling control. The ECM monitors the voltage on pin 23. The ECM expects to see the voltage vary between 0.5 and 4.88 VDC. If the

voltage is above 4.88 VDC, the ECM will log Fault Code 153. Voltage above 4.88 VDC on pin 23 can be caused by openings in the signal or return wires, voltage shorts to the signal or return wires, or a failed open sensor.

Refer to Troubleshooting Fault Code t05-153 (</qs3/pubsys2/xml/en/procedures/19/19-t05-153.html>)
