Maintenance Check

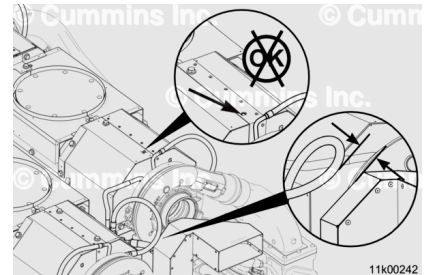
Check for clearance between heat shields and engine fluid lines such as fuel supply lines, coolant pipes, oil lines.

If there is **not** a minimum of 2mm clearance the heat shields **must** be adjusted to prevent contact.

Inspect for missing or loose capscrews. Any missing capscrews **must** be replaced.

Ensure heat shield capscrews are torqued correctly.

Torque Value: 54 n•m [40 ft-lb]

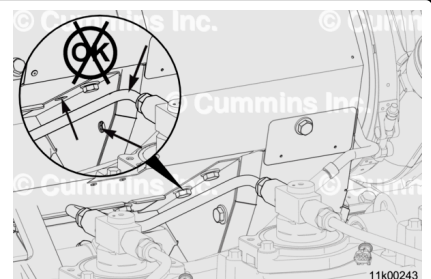
Right Bank Front Fuel line:

Check for clearance between right bank front fuel line supplying cylinder 2-3 and heat shield.

Complete visual inspection of fuel line to ensure no rubbing or scoring marks are present. If any such wear is witnessed, replace damaged hard section of fuel line.

If clearance is less than 2mm, heat shield **must** be adjusted to increase clearance.

Check capscrew torques of critical fastening locations as shown in diagram and replace any capscrews if missing.

Torque Value: 54 n•m [40 ft-lb]

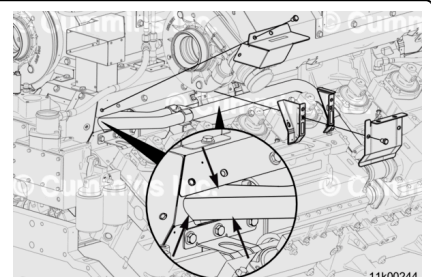
Left Bank Front LTA Pipes:

Remove cover part as shown in the diagram.

Complete visual inspection and check clearance between the heat shield LTA coolant pipes as shown in the diagram.

Check surrounding capscrew torques and replace any missing capscrews.

Torque Value: 54 n•m [40 ft-lb]

If any contact is seen between the coolant pipe and heat shield, heat shield **must** be adjusted to increase clearance. Check pipe for wear or damage.

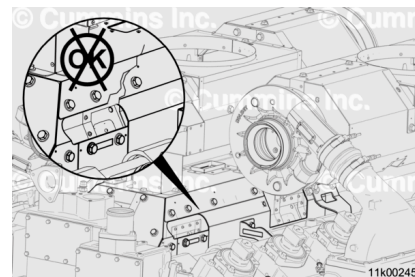
Complete visual inspection of bracket as shown in diagram for cracks or damage. If any cracks are observed, bracket **must** be replaced.

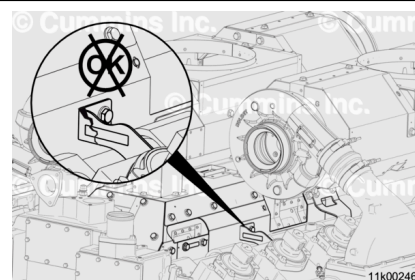
Complete visual inspection of bracket as shown in diagram for cracks or damage. If any cracks are observed, bracket **must** be replaced.
