Fault Code: 621

Exhaust Gas Temperature Deviation Low for Cylinder 1 - Data Valid But Below Normal Operating Range - Least Severe Level

Exhaust Gas Temperature Sensor Circuit Cylinder 1 - QSK45 and QSK60 Engines

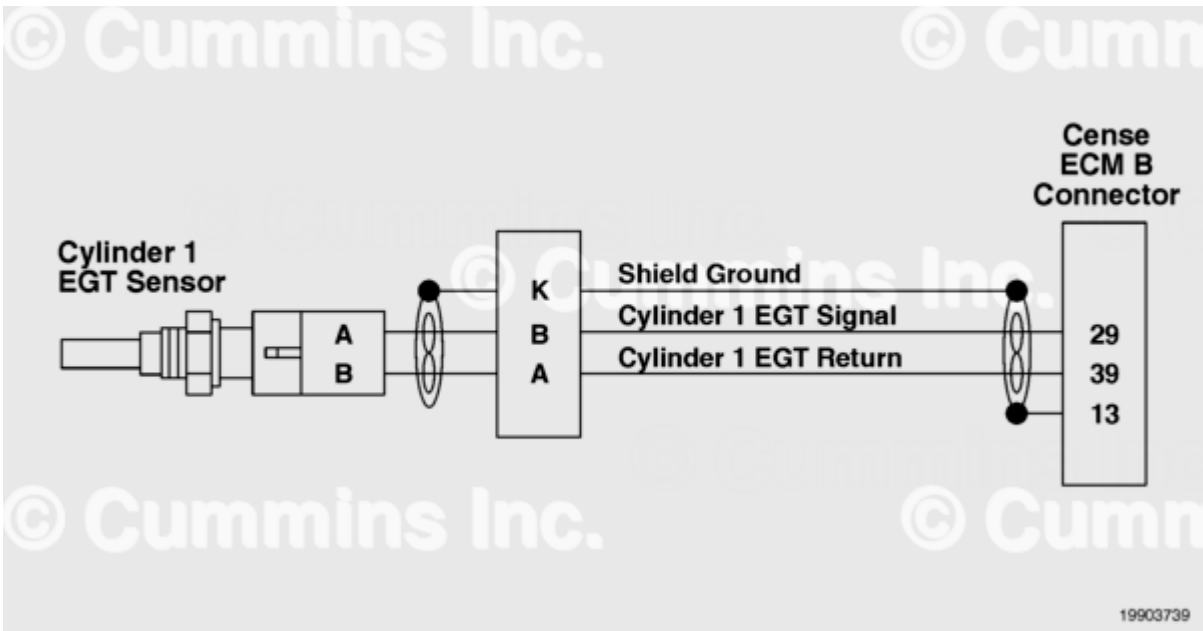
The exhaust gas temperature sensor circuit cylinder 1 monitors exhaust gas temperature and passes information to the engine control module (ECM) through the engine harness.

The exhaust gas temperature sensor circuit cylinder 1 for this fault code is located in the exhaust manifold at the cylinder head 1 to exhaust manifold interface.
