Fault Code: 632

Exhaust Gas Temperature Deviation Low for Cylinder 4 - Data Valid But Below Normal Operating Range - Least Severe Level

Exhaust Gas Temperature Sensor Circuit Cylinder 4 - QSK45 and QSK50 Engines

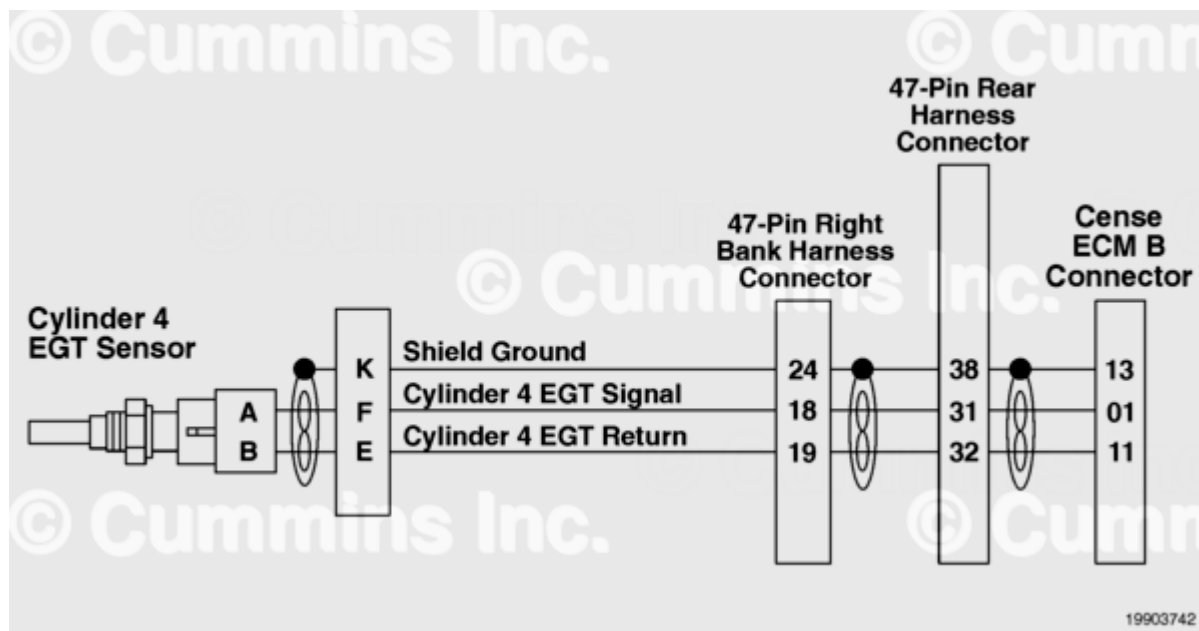
The exhaust gas temperature sensor circuit cylinder 4 monitors exhaust gas temperature and passes information to the engine control module (ECM) through the engine harness.

The exhaust gas temperature sensor circuit cylinder 4 for this fault code is located in the exhaust manifold at the cylinder head 4 to exhaust manifold interface.
