Fault Code: 635

Exhaust Gas Temperature Deviation Low for Cylinder 10 - Data Valid But Below Normal Operating Range - Least Severe Level

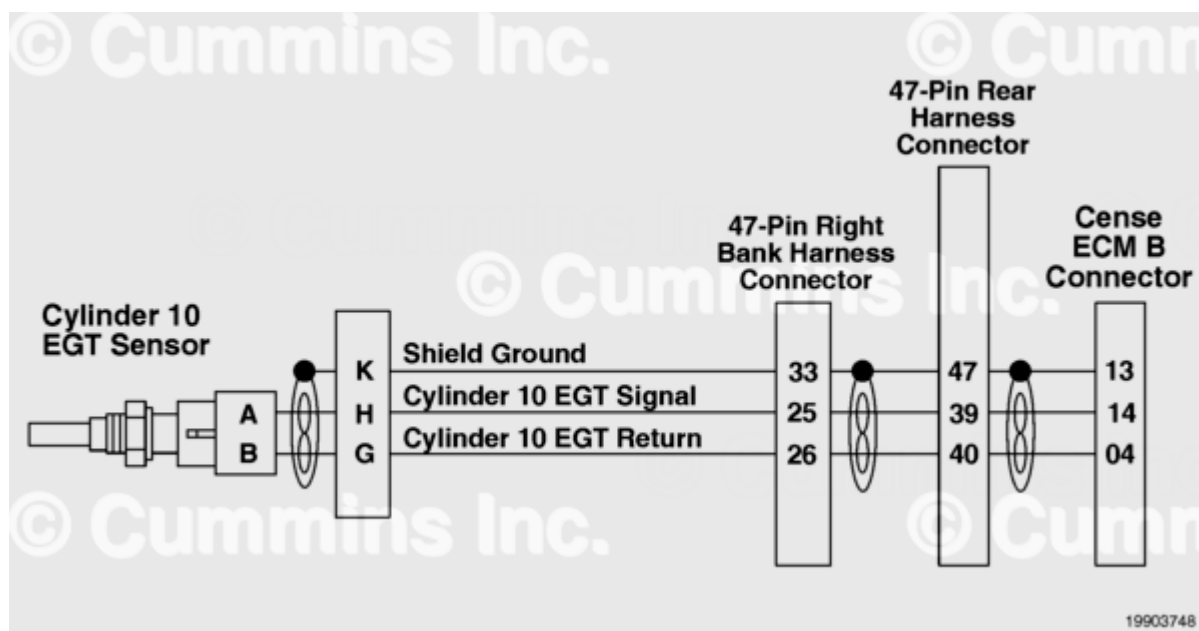
Exhaust Gas Temperature Sensor Circuit Cylinder 10 - QSK45 and QSK60 Engines

The exhaust gas temperature sensor circuit cylinder 10 for this fault code is located in the exhaust manifold at the cylinder head 10 to exhaust manifold interface.
