Technical Service Bulletin: tsb100608

Released Date: 23-Jul-2007

New Flat Cooling Plate Pistons

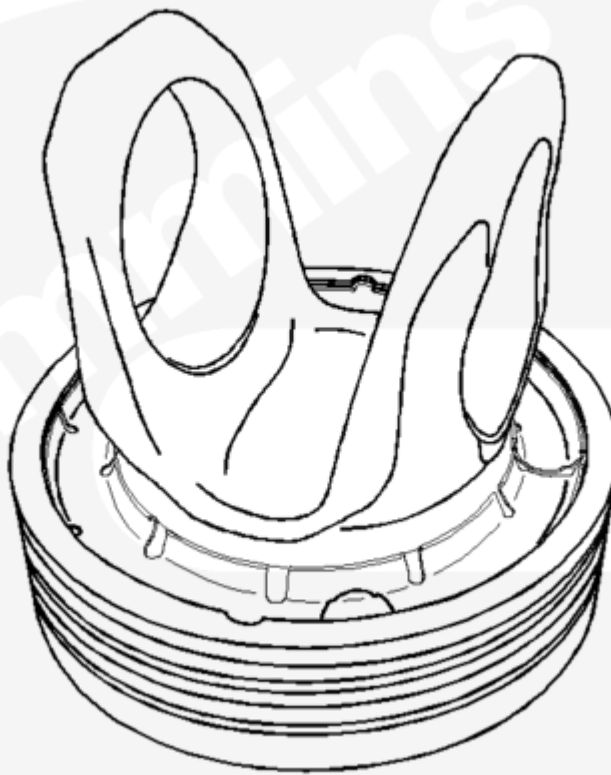
Figure 1, Domed Plate Segments

The underside of the articulated piston crown has two domed plates that form the piston cooling gallery. The oil that flows through this gallery removes heat from the piston crown. The domed plates are **not** serviceable. Refer to Figure 1 to see this design.

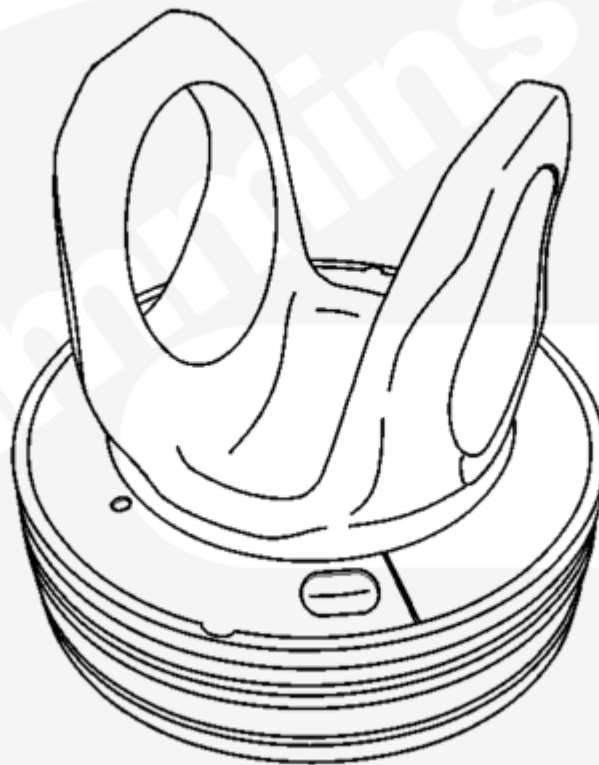
Figure 2, Flat Plate Segments

Three new flat cooling plate pistons have been released. The underside of the crown has been redesigned with two nonserviceable flat cooling plate segments. Refer to Figure 2 to see this design.

When an M11 industrial engine (CPL 2119, 2336, 2363, 2503, 2916, 2917, 2918, 2828, and 2829) is repaired or rebuilt with the new flat cooling plate pistons, the engine dataplate **must** be stamped with FFNR-8.

When an M11 Plus automotive engine (CPL 2036, 2037, 2370, and 2371) is repaired or rebuilt with the new flat cooling plate piston, the engine dataplate **must** be stamped with FF255. Targeted applications include refuse/disposal trucks, mixers, food delivery, dump trucks, and bulk haulers.

When an ISM automotive engine (CPL 2607 and 2608) is repaired or rebuilt with a new flat cooling plate piston, the engine dataplate **must** be stamped with FF337. Targeted applications include refuse/disposal trucks, highway department/DOT dump trucks, and mixers.

| New Piston Kits | | |
|---|---|---|
| NOTE: Repairs and rebuilds with the new pistons/kits <b>must</b> be done in complete engine sets, due to piston weight differences. | | |
