Fault Code: 115

Engine Speed Sensor Circuit

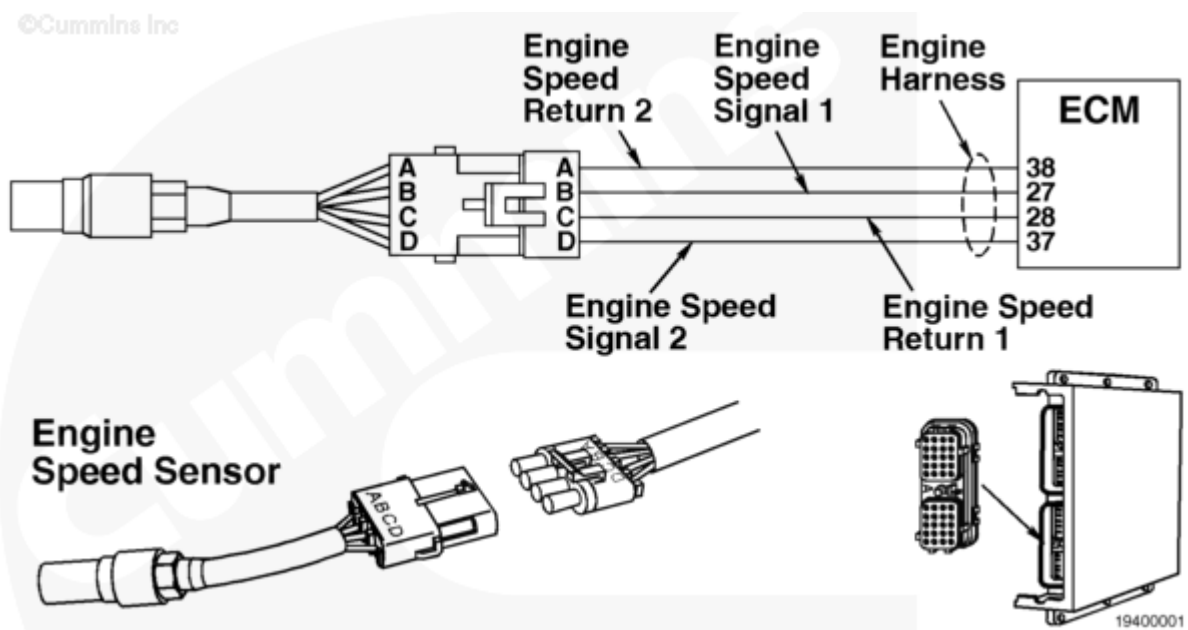
Engine Speed Sensor Circuit

The engine speed sensor is a dual-coil circuit that provides the engine speed signal to the ECM through the engine harness.

The engine speed sensor is located above the accessory drive.

- If the problem occurs **only** at a certain engine temperature, be sure to check the engine speed sensor (engine speed sensor) circuit while the engine is at that particular temperature.
- Check camshaft end play to make sure that the camshaft gear is **not** moving too far away from the end of the engine speed sensor.
