Fault Code: 233

Coolant Pressure - Engine Protection

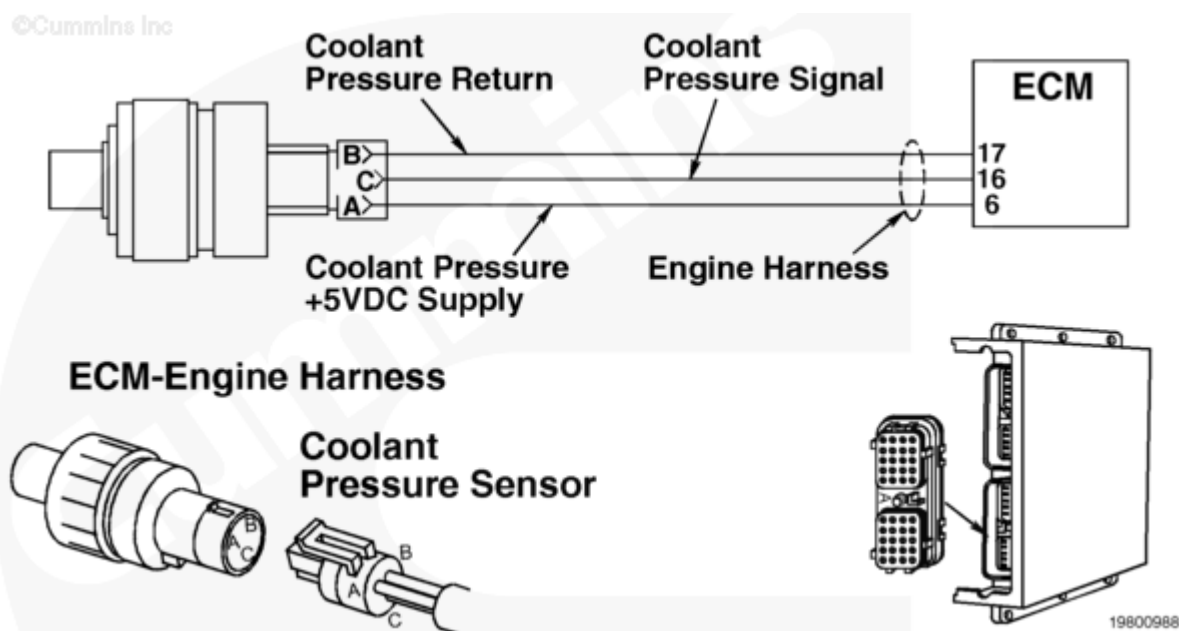
Coolant Pressure Sensor Circuit

The coolant pressure sensor is used by the ECM to monitor the coolant pressure. The ECM monitors the voltage on the signal pin and converts this to a pressure value. The coolant pressure value is used by the ECM for the engine protection system.

The coolant pressure sensor is located on the exhaust side of the engine, below the oil cooler.
