Fault Code: 122

Intake Manifold Pressure Sensor Circuit - Shorted High

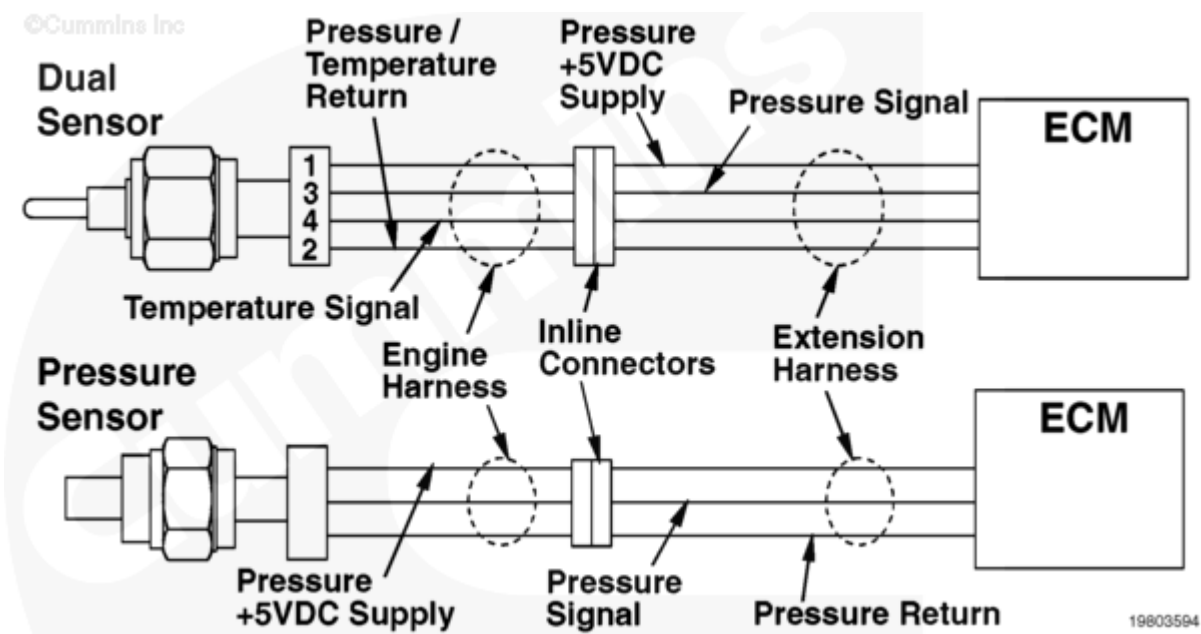
Intake Manifold Pressure Sensor 1 Circuit

The intake manifold pressure sensor monitors boost pressure and passes information to the electronic control module (ECM). High voltage will trip Fault Code 122 and can be caused by shorts in the supply, signal, or return wires, an open in the return wire, or a failed sensor.
