Fault Code: 1319

Alternator Temperature - Alternator Protection

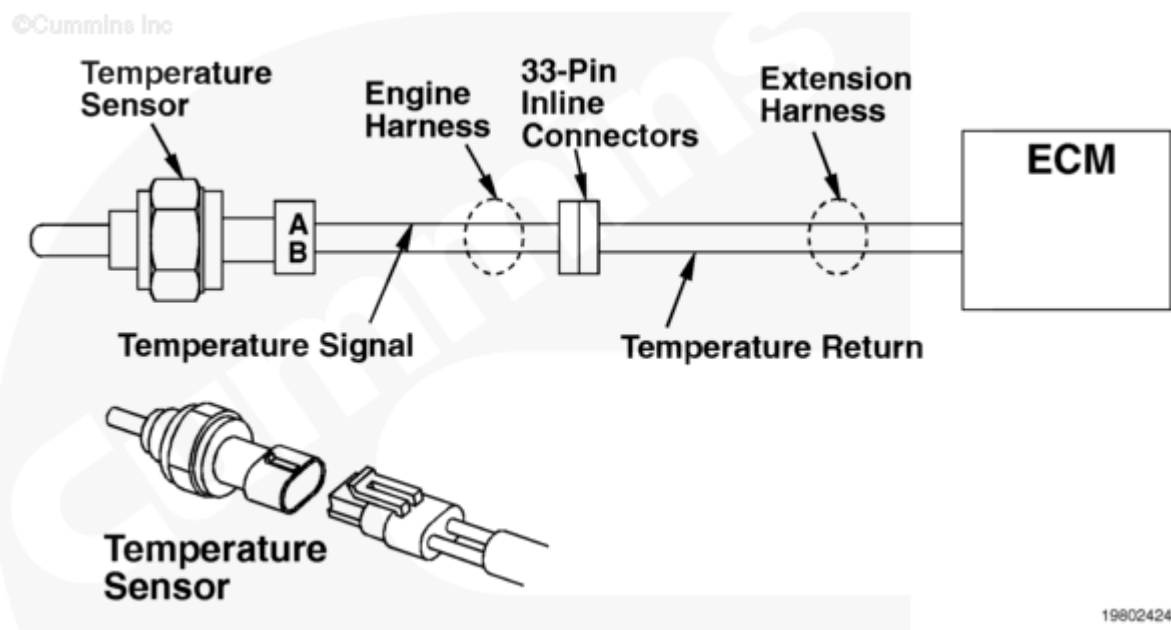
Alternator Temperature Sensor Circuit

The alternator temperature sensor is used by the electronic control module (ECM) for the generator set protection system. The ECM monitors the temperature of the alternator and informs the operator, via the warning lamp, that the alternator temperature has increased past the warning threshold for alternator temperature. The ECM monitors the voltage on the alternator temperature signal pin and expects to see a voltage vary between 0.5 and 4.5 VDC during normal engine operation.

Make sure that the alternator is being properly cooled/ventilated.
