Fault Code: 159

Intake Manifold Temperature Sensor Number 2 Circuit - Shorted High

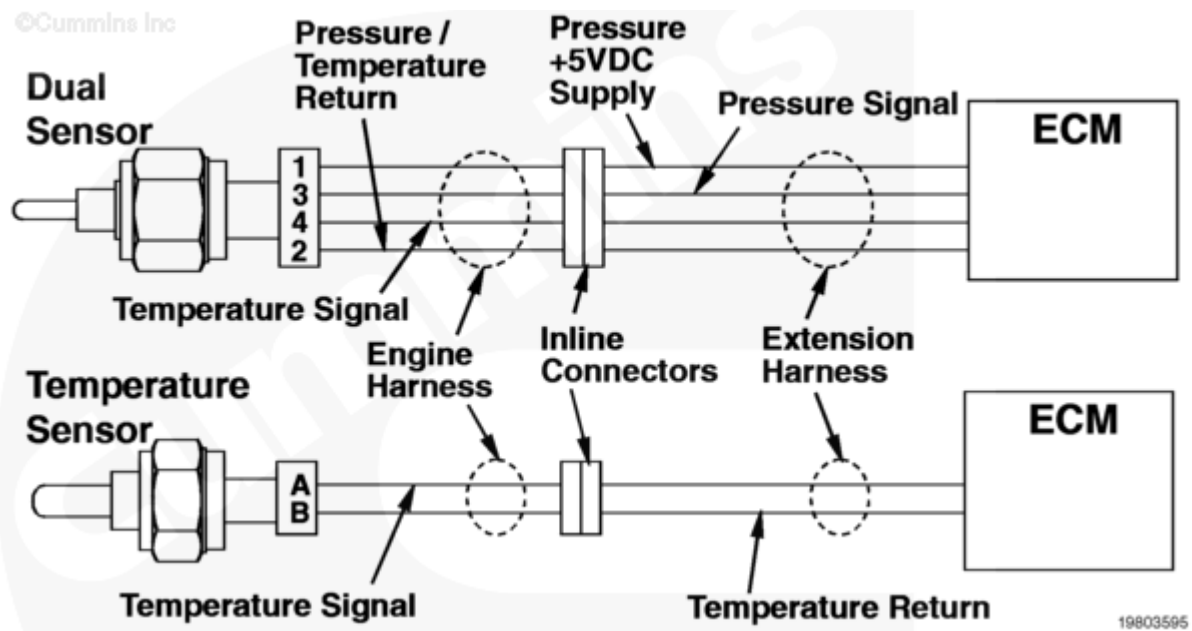
Intake Manifold Temperature Sensor Circuit

The intake manifold temperature sensor Number 2 is used by the ECM to monitor the temperature of the air in the intake manifold after the aftercooler. The intake manifold temperature sensor Number 2 is used by the ECM for the timing and fueling control. If the voltage is high, the ECM will log Fault Code 159. Voltage high can be caused by opens in the signal or return wires, voltage shorts to the signal or return wires, or a failed open sensor.
