Fault Code: 161

Intake Manifold Temperature Sensor Number 2 Circuit - Shorted Low

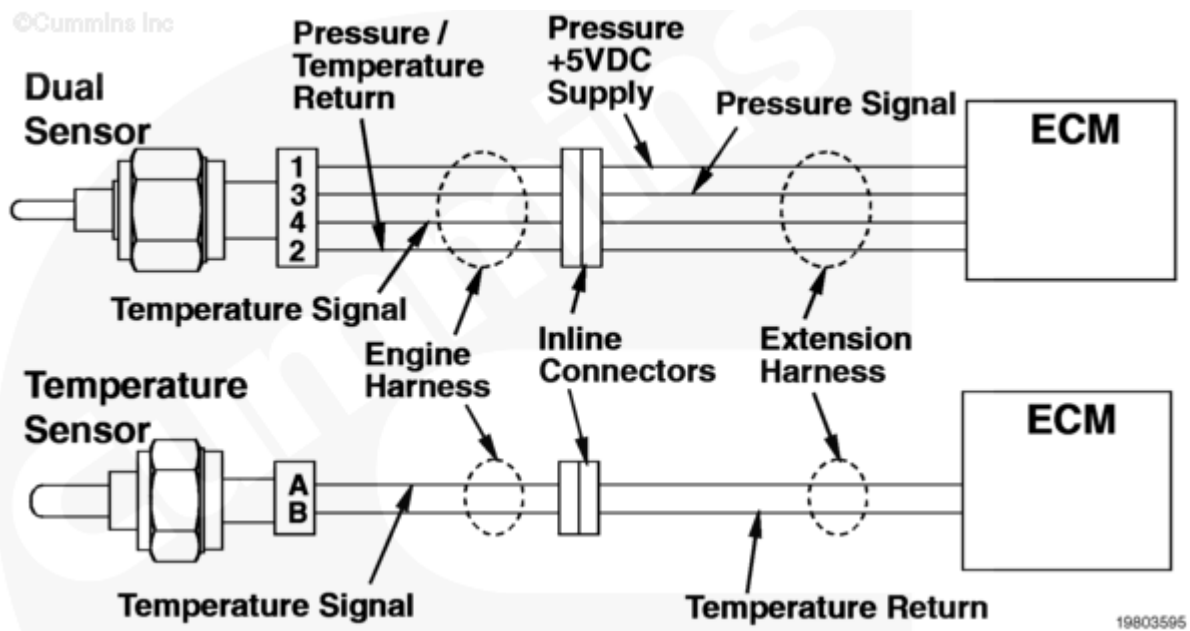
Intake Manifold Temperature Sensor Circuit

The intake manifold temperature sensor Number 2 is used by the ECM to monitor the temperature of the air in the intake manifold downstream of the aftercooler element. The intake manifold temperature is used by the ECM for the engine protection system, timing, and fueling

control. If the voltage is low, the ECM will log Fault Code 161. Low voltage can be caused by shorts to engine block ground on the supply or return wires or an internally grounded failed sensor.
