Fault Code: 231

Engine Coolant Pressure Sensor Circuit - Shorted High

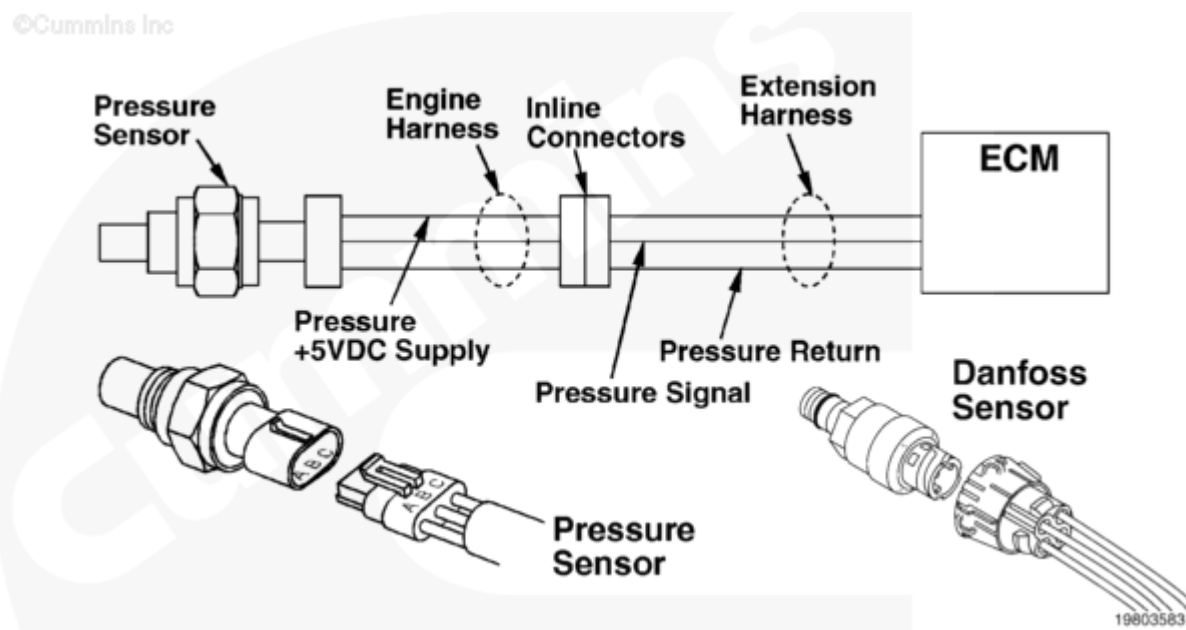
Coolant Pressure Sensor Circuit

The coolant pressure sensor monitors coolant pressure and passes information to the electronic control module (ECM). High voltage will trip Fault Code 231 and can be caused by shorts in the supply, signal, or return wires, an open in the return wire, or a failed sensor.
