Fault Code: 232

Coolant Pressure Sensor Circuit - Shorted Low

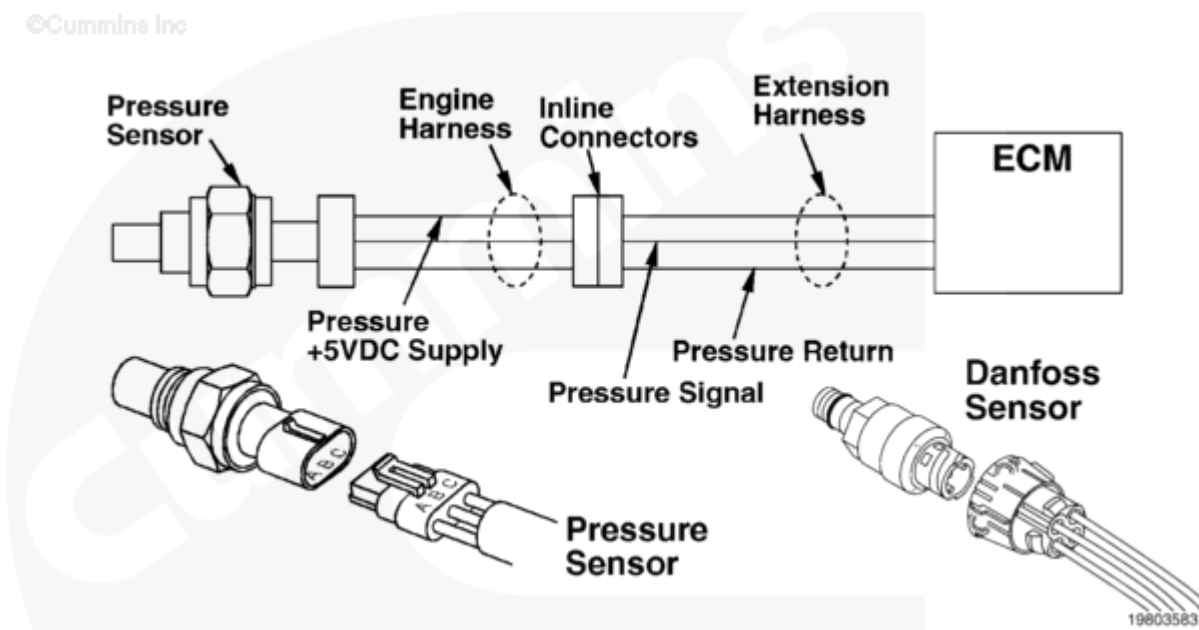
Coolant Pressure Sensor Circuit

The coolant pressure sensor monitors coolant pressure and passes information to the engine control module (ECM). Low voltage will trip Fault Code 232 and can be caused by shorts in the supply, signal, or return wires, an open in the return wires, or a failed sensor.
