Fault Code: 379

Fueling Actuator Number 1 - Grounded Circuit (Front)

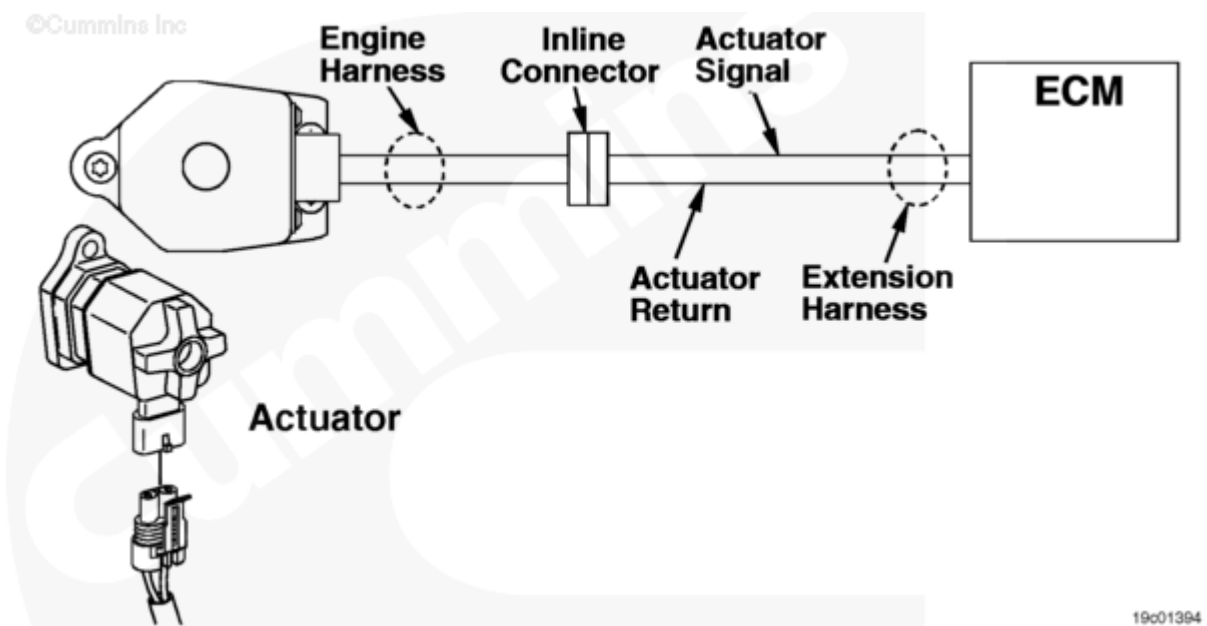
Fueling Actuator Number 1 Circuit

Codes	Reason	Effect
Fault Code: 379 PID(P): SPN: FMI: Lamp: Shutdown SRT:	Fueling actuator Number 1 circuit - grounded circuit. (front)	Engine will shut down.

The fueling actuators are actuated by the ECM to control fuel metering. Each fueling actuator is connected to the ECM by a supply and a return wire. An electrical pulse is sent to the fueling actuator from the ECM on the supply wire and returns to the ECM on the return wire. Each solenoid valve is normally closed, and it is **only** opened by an electrical pulse from the ECM during metering.

The possible failure modes are short to battery, low actuator resistance, or short between supply and return wires.

Refer to Troubleshooting Fault Code t05-379 (</qs3/pubsys2/xml/en/procedures/01/01-t05-379.html>)
