Fault Code: 123

Intake Manifold Pressure Sensor Circuit - Voltage Below Normal or Shorted to Low Source

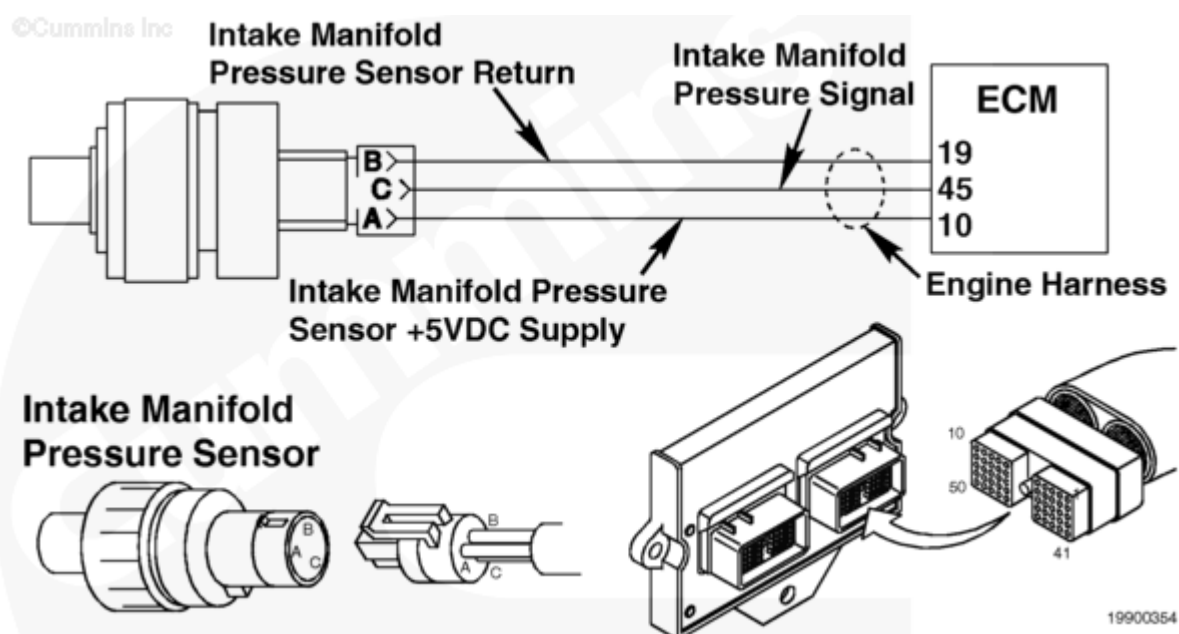
Codes	Reason	Effect
Fault Code: 123 PID(P): P102 SPN: 102 FMI: 4 Lamp: Amber SRT:	Intake Manifold Pressure Sensor Circuit - Voltage Below Normal or Shorted to Low Source. Low signal voltage detected at the intake manifold pressure circuit.	Derate dependant on calibration.

The intake manifold pressure sensor monitors boost pressure and passes information to the electronic control module (ECM) through the intake manifold pressure signal pin of the engine harness.

Reference Section E for a detailed component location view. There is one intake manifold pressure sensor on the 480C E engine. It is located next to the air intake heater, behind the ECM.

- The intake manifold pressure sensor measures gauge pressure. Confirm the sensor is reading properly by comparing the reading seen in the ECM with a reading taken with a mechanical gauge. The sensor should read -38 to 38 mm Hg [-1.5 to 1.5 in Hg] using INSITE™, with the keyswitch turned to the ON position, but the engine **not** running.
- Check for high restriction in the intake manifold due to clogged air filters or a shutdown device in the manifold (if the vessel is equipped with one). Do **not** remove this device. If the engine is operated in a flammable atmosphere, the device is an essential safety feature.
- Make sure the turbocharger is working correctly. Check for a positive intake manifold pressure.
