Fault Code: 132

Throttle Position Signal Circuit - Low Voltage

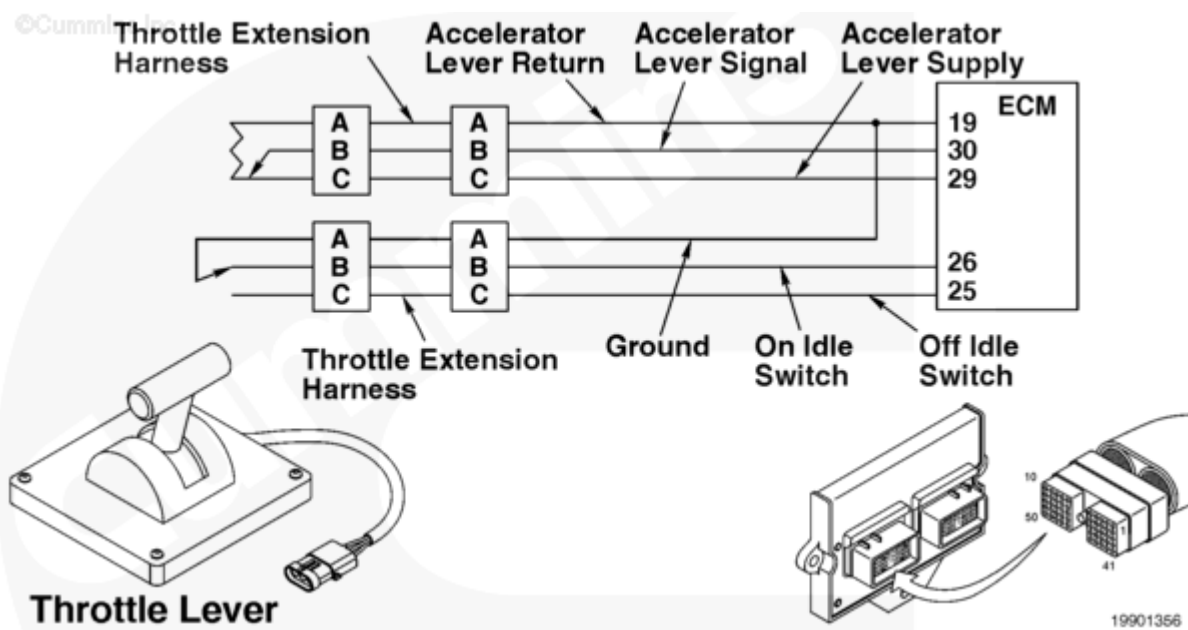
Throttle Position Signal Circuit

The accelerator pedal/lever provides the driver's accelerator command to the electronic control module (ECM) through the marine OEM harness and the throttle extension harness. The ECM uses this signal to determine the fueling command for the P7100 fuel pump rack.
