Fault Code: 144

Coolant Temperature Sensor Circuit - Voltage Above Normal or Shorted to High Source

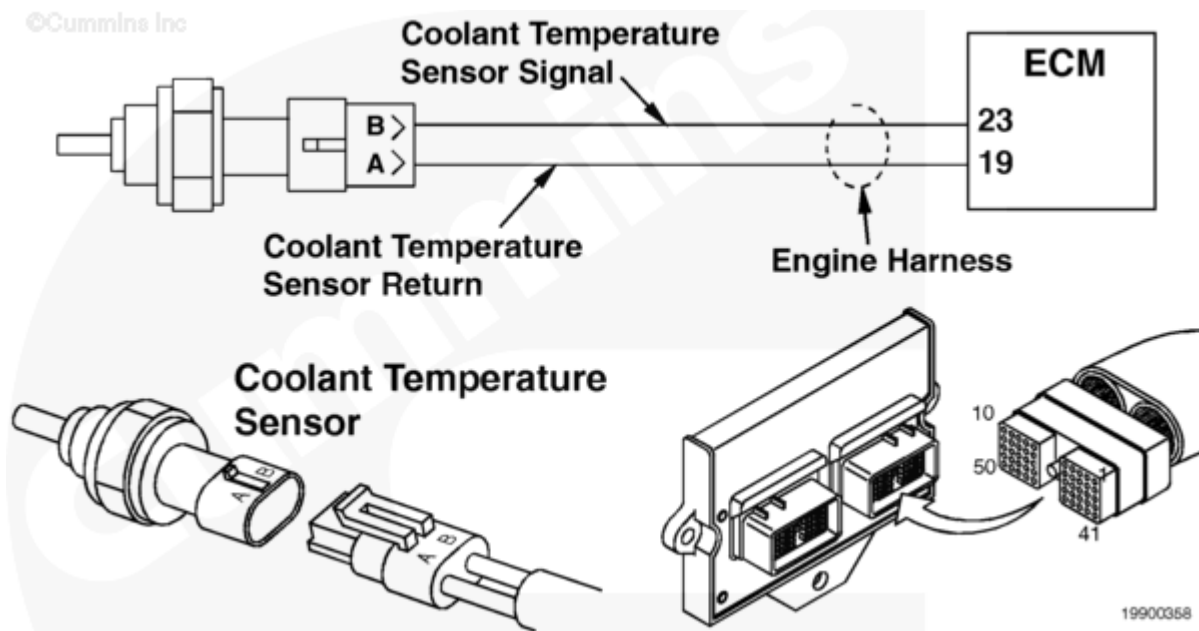
Coolant Temperature Sensor Circuit

Codes	Reason	Effect
Fault Code: 144 PID(P): P110 SPN: 110 FMI: 3 Lamp: Amber SRT:	Coolant temperature sensor circuit - voltage above normal or shorted to high source.	Engine protection for coolant temperature is disabled. Possible white smoke.

The coolant temperature sensor is used by the electronic control module (ECM) to monitor the temperature of the engine coolant. The coolant temperature is used by the ECM for the engine protection system, timing, and fueling control.

Reference Section E for a detailed component location view. The coolant temperature sensor is located in the thermostat housing.

Refer to Troubleshooting Fault Code t05-144 (</qs3/pubsys2/xml/en/procedures/07/07-t05-144.html>)
