Fault Code: 418

Water In Fuel Indicator - Data Valid But Above Normal Operating Range - Least Severe Level

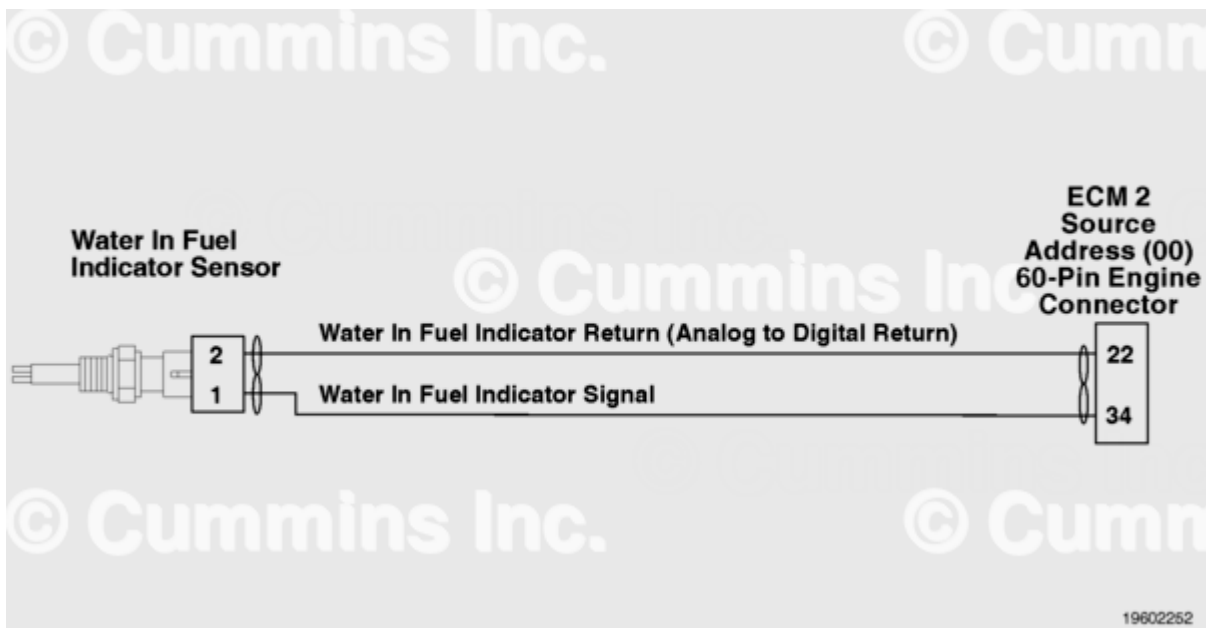
QSK38 CM2150 Industrial/QSK38 CM2150 Marine with C Command™ Panel System - Water in Fuel Indicator Sensor Circuit

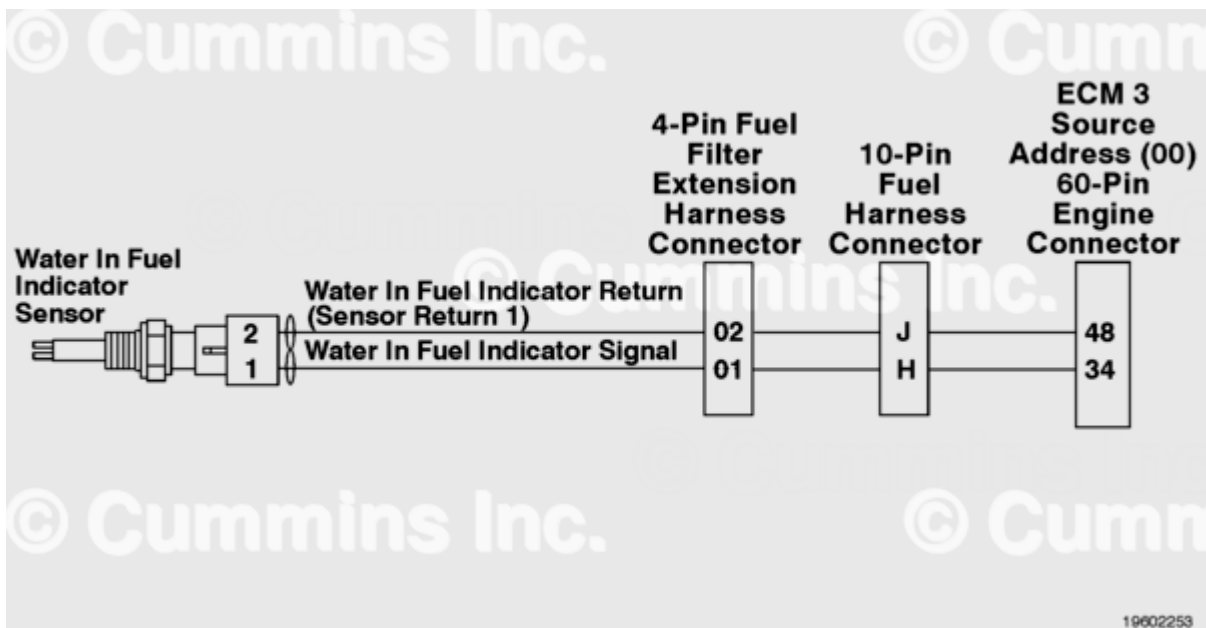
QSK38 CM2150 Marine with C Command Elite™ and C Command Elite Plus™ Panel System - Water in Fuel Indicator Sensor Circuit

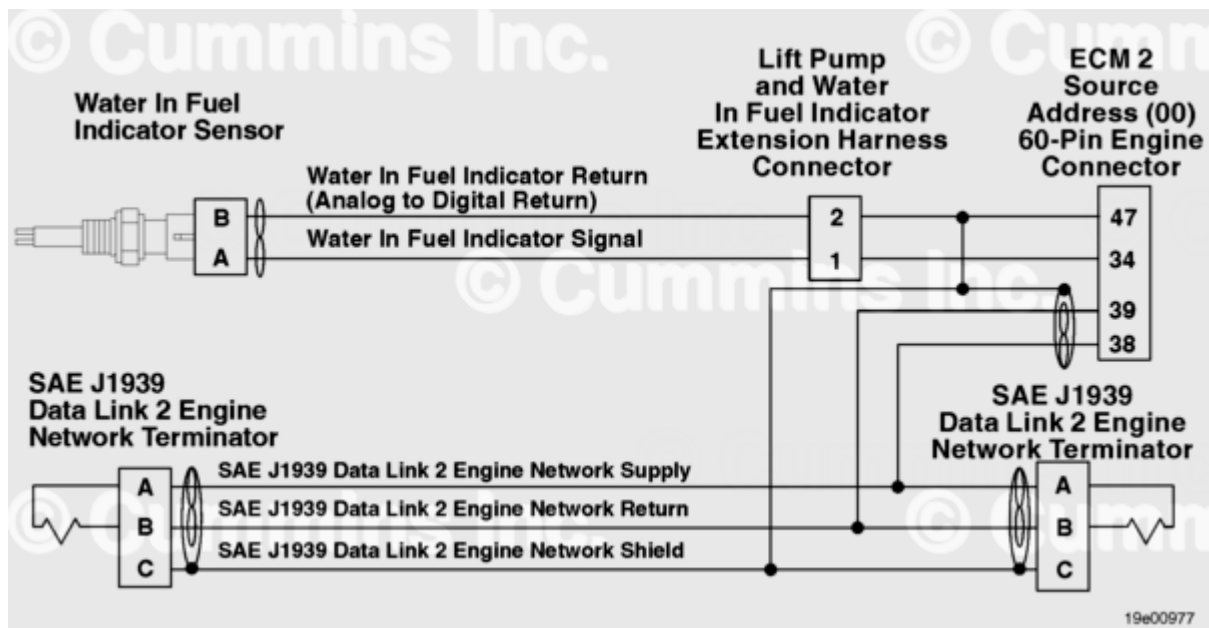
QSK50 CM2150 Industrial - Water in Fuel Indicator Sensor Circuit

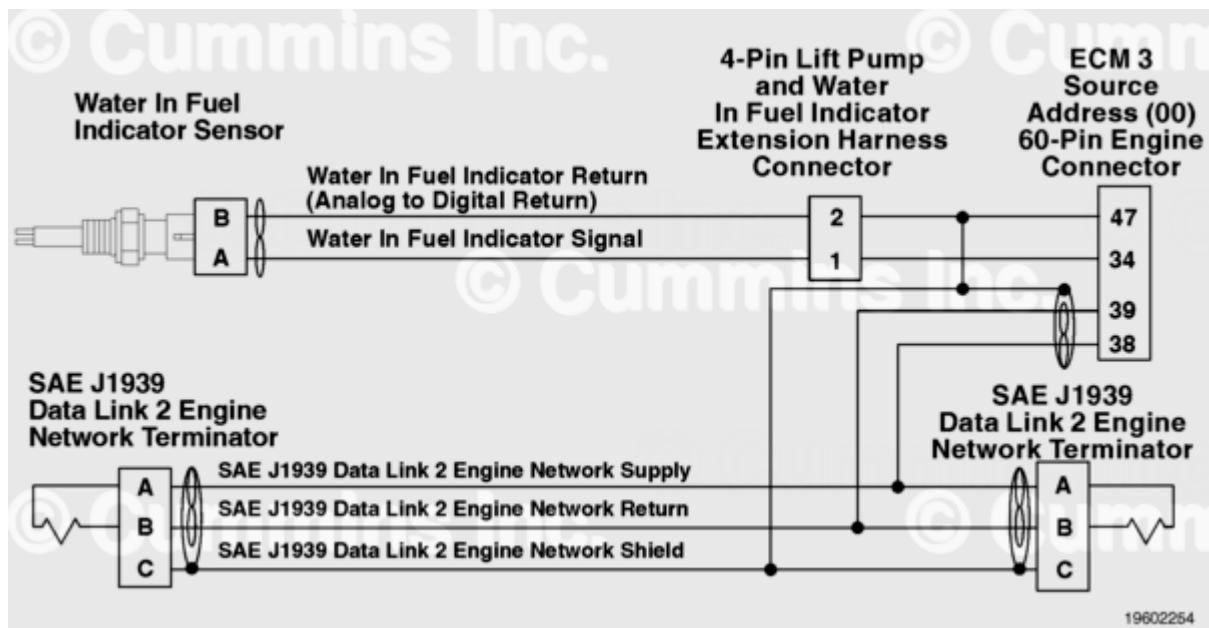
QSK38 CM2150 Power Generation and QSK38 CM2150 Power Generation (Military Application) - Water in Fuel Indicator Sensor Circuit

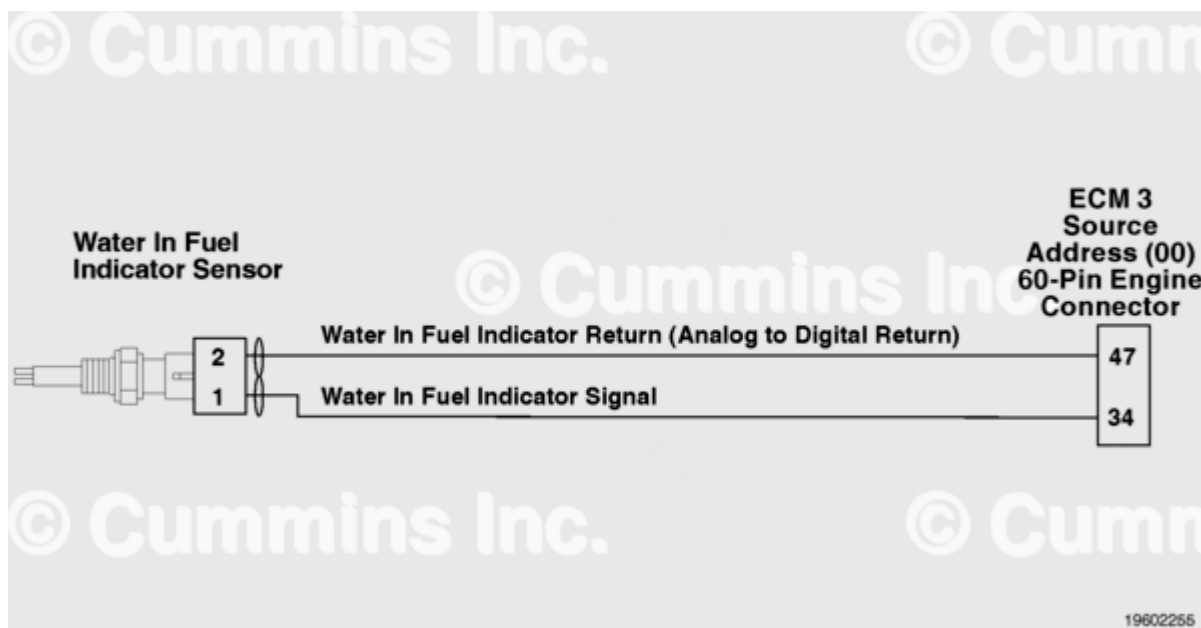
QSK50 CM2150 Power Generation with Advanced Engine Monitoring/QSK50 CM2150 Power Generation without Advanced Engine Monitoring/QSK60 CM2150 Power Generation - Water in Fuel Indicator Sensor Circuit

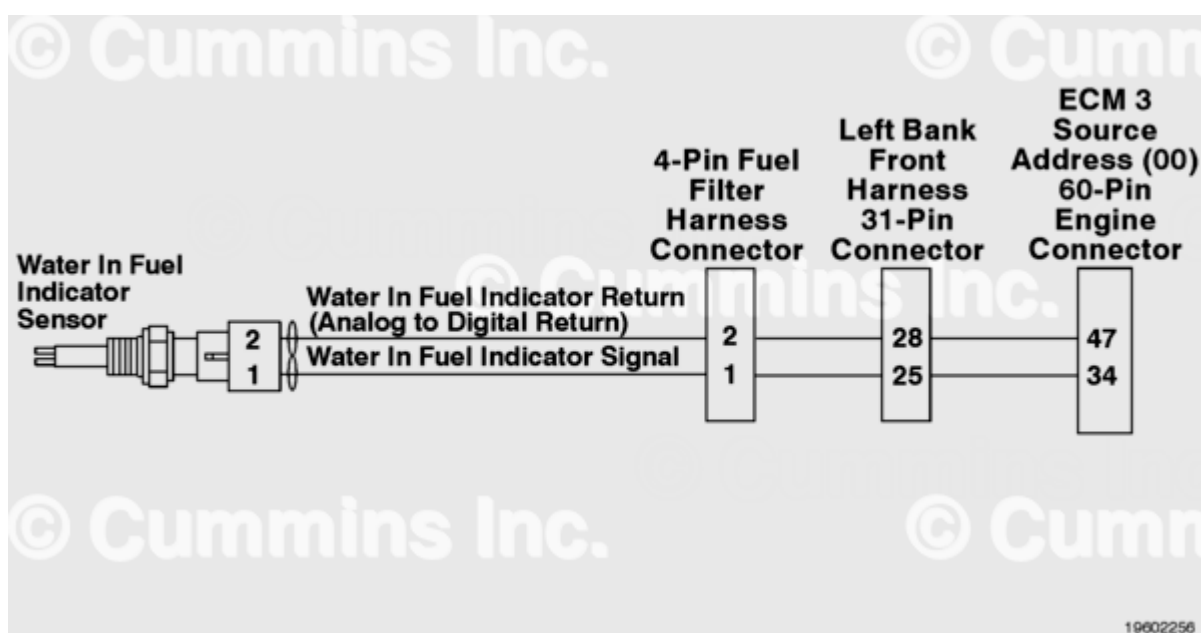
QSK50 and QSK60 CM2150 Marine/QSK60 CM2150 Drill Rig - Water in Fuel Indicator Sensor Circuit
