Fault Code: 522

Transmission Oil Temperature Sensor Circuit - Voltage Below Normal or Shorted to Low Source

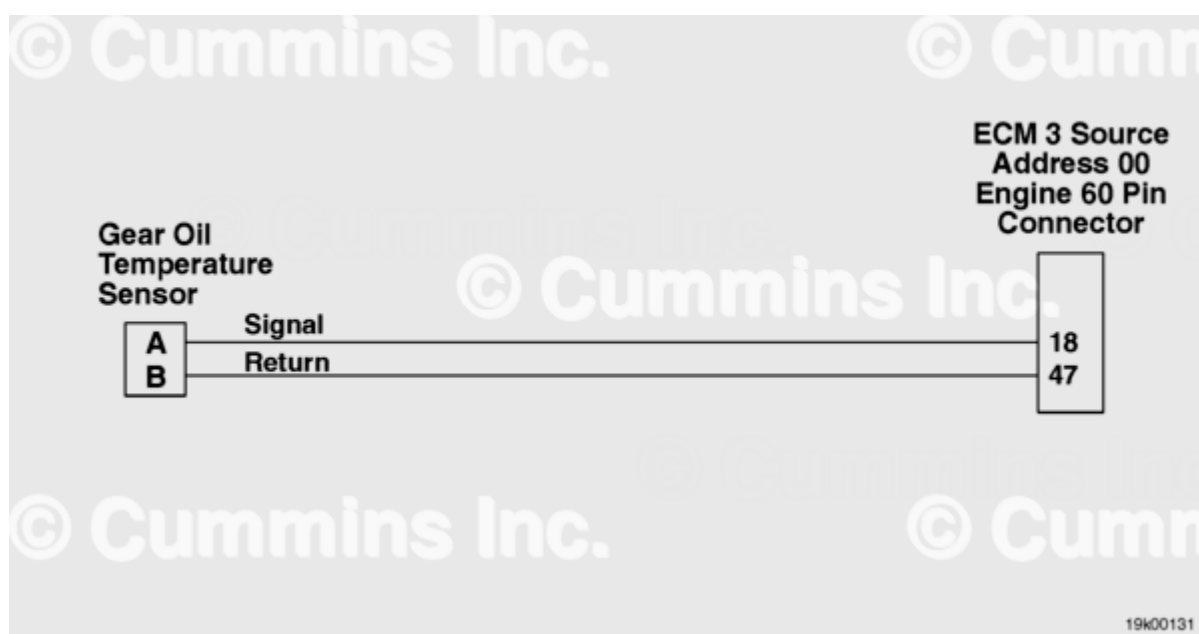
Transmission (Gear) Oil Temperature Sensor Circuit

Transmission (gear) oil temperature sensor is used by the engine control module (ECM) to monitor the transmission oil temperature. The ECM monitors the voltage on the SIGNAL pin and converts it to a temperature value.

The transmission (gear) oil temperature sensor shares RETURN wires in the engine harness with other sensors. A shorted return can cause multiple fault codes to be active. Before troubleshooting Fault Code 522, check for multiple fault codes.

- Signal shorted to ground in the harness.
- Signal shorted to return or ground in the sensor.
