Fault Code: 2998

Engine Torque Limit Feature - Special Instructions

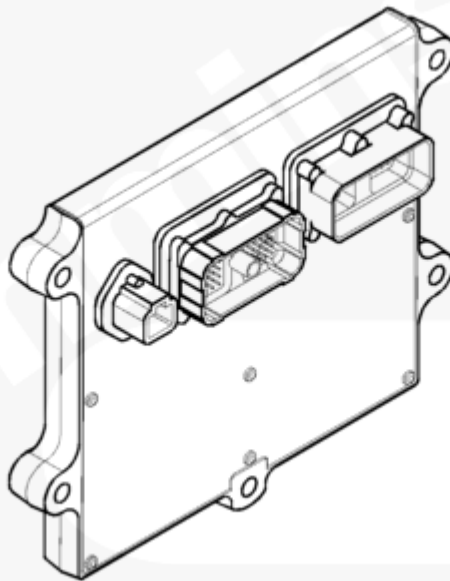
19c01042

Codes	Reason	Effect
Fault Code: 2998 PID(P): SPN: 1632 FMI: 14 Lamp: Amber SRT:	Engine Torque Limit Feature - Special Instructions. Engine overloaded.	Possible engine derate if enabled.

This fault code is designed to keep the engine from overloading.

The fault code is triggered when the engine speed fails to attain the commanded speed.

Potential causes of this fault code are:

- Low engine power
- High idle adjustment is too high
- Excessive hull fouling
- Incorrect transmission or propeller.

Refer to the OEM service manual for causes associated with excessive hull fouling and incorrect transmission or propeller, as these are external to engine.

Refer to Troubleshooting Fault Code 2998. (</qs3/pubsys2/xml/en/procedures/123/123-t05-2998.html>)
