Fault Code: 521

Transmission Oil Temperature Sensor Circuit - Voltage Above Normal or Shorted to High Source

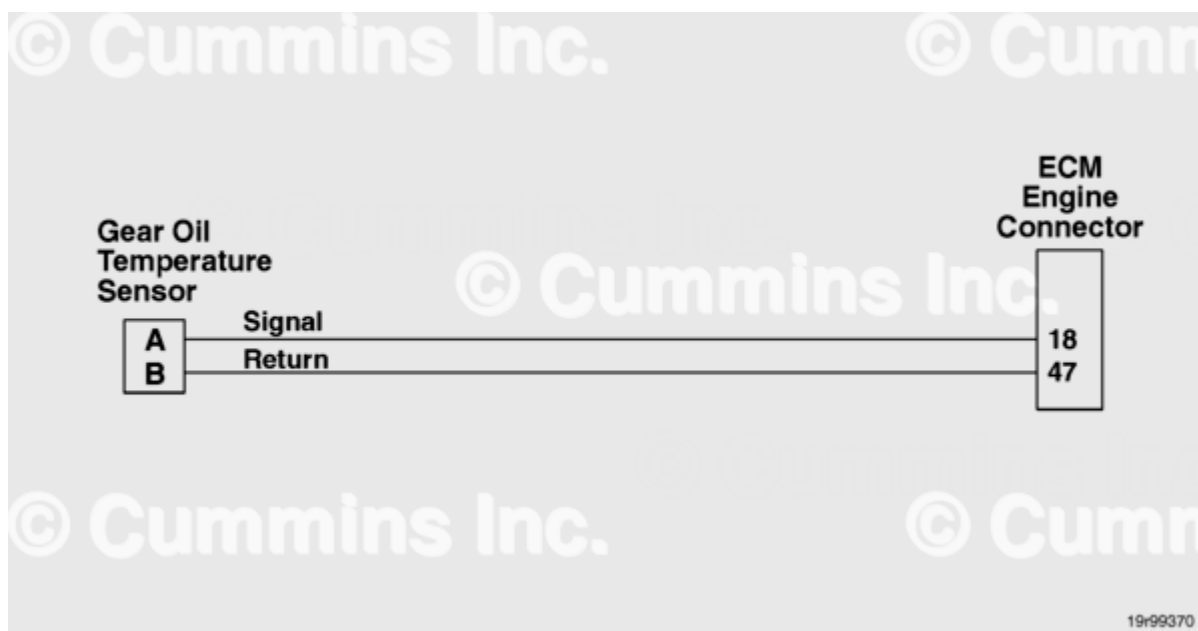
Codes	Reason	Effect
Fault Code: 521 PID(P): SPN: 175 FMI: 3 Lamp: Amber SRT:	Transmission (Gear) Oil Temperature Sensor Circuit - Voltage Above Normal or Shorted to High Source. High signal voltage detected at transmission (gear) oil temperature sensor circuit.	No engine protection for transmission oil temperature.

The transmission (gear) oil temperature sensor share RETURN wires in the engine harness with other sensors. An open return can cause multiple fault codes to be active.

- Open return circuit in the harness, connectors, or sensor
- Open signal circuit or shorted to a voltage source.

Before troubleshooting Fault Code 521, check for multiple faults.

Refer to Troubleshooting Fault Code 521. (</qs3/pubsys2/xml/en/procedures/123/123-t05-521.html>)
