Technical Service Bulletin: TSB150179

Released Date: 03-Dec-2015

New Valve Camshaft Removal and Installation Service Tool Kit

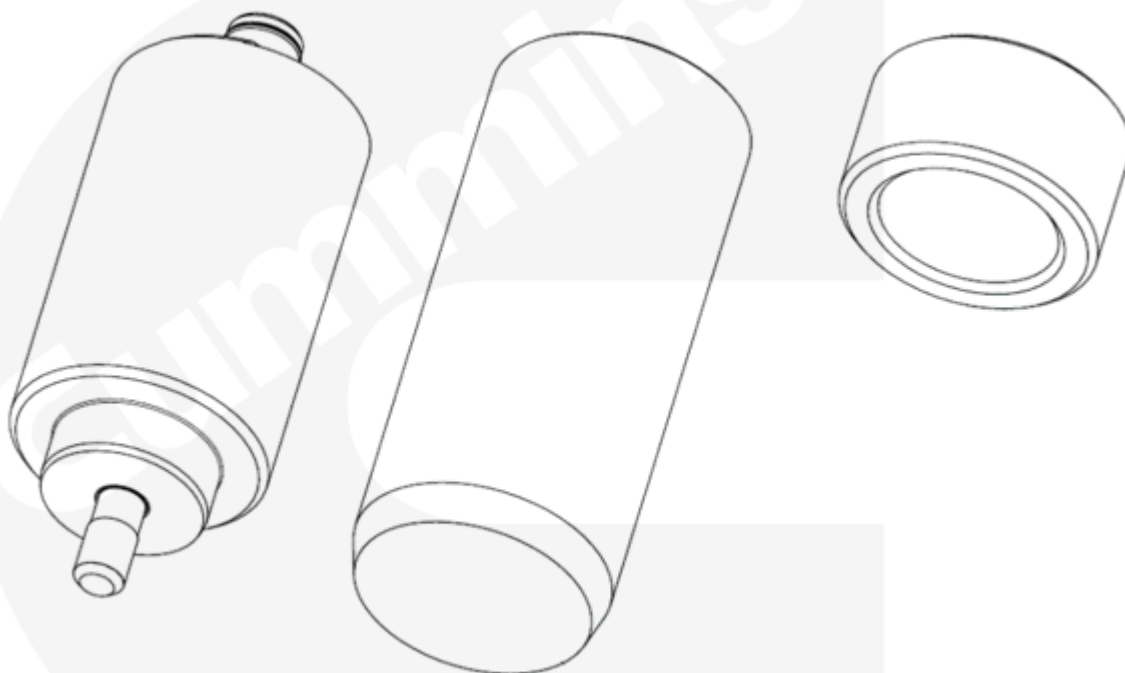
22r00035

Figure 1, Valve Camshaft Removal and Installation Service Tool Kit. From Left: 5299844, 5299839, and 5299841
