Fault Code: 164

Intake Manifold 4 Temperature Sensor Circuit - Voltage Below Normal or Shorted to Low Source

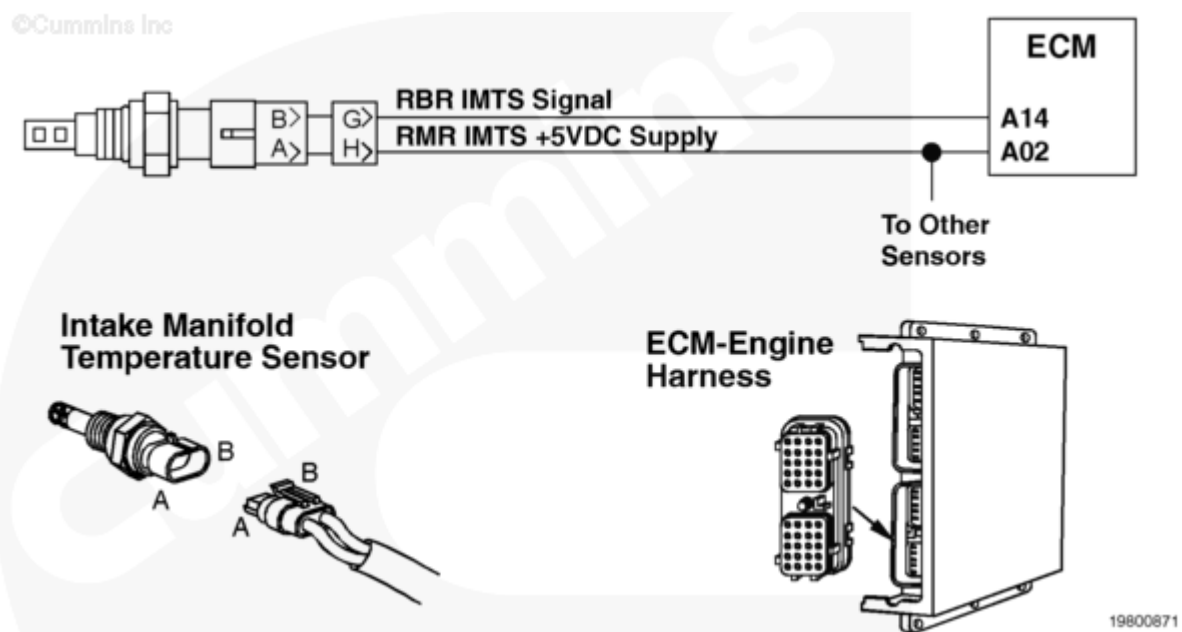
Codes	Reason	Effect
Fault Code: 164 PID(P): 105 SPN: 1133 FMI: 4 Lamp: Yellow SRT: 00-699	Intake Manifold 4 Temperature Sensor Circuit - Voltage Below Normal or Shorted to Low Source. Low voltage detected on SIGNAL pin-14 of the main harness A engine control module (ECM) connector.	Fault Code 165 is disabled.

The intake manifold 4 temperature sensor circuit provides the right bank rear intake air temperature signal to the ECM. The resistance of the sensor varies with temperature. The ECM detects the change in resistance of the sensor by monitoring the voltage across an internal

resistor that is in series with the sensor. The change in voltage across the internal resistor is translated into a temperature change.

The right bank rear intake manifold temperature sensor is located on the right bank rear intake manifold. The sensor is located downstream of the aftercooler.

Refer to Troubleshooting Fault Code t05-164. (</qs3/pubsys2/xml/en/procedures/81/81-t05-164.html>)
