Technical Service Bulletin: TSB130183	Released Date: 09-Jan-2014
Diesel Exhaust Fluid Doser Pump Override Test Enumeration 13

Diesel Exhaust Fluid Doser Pump Override Test Enumeration 13

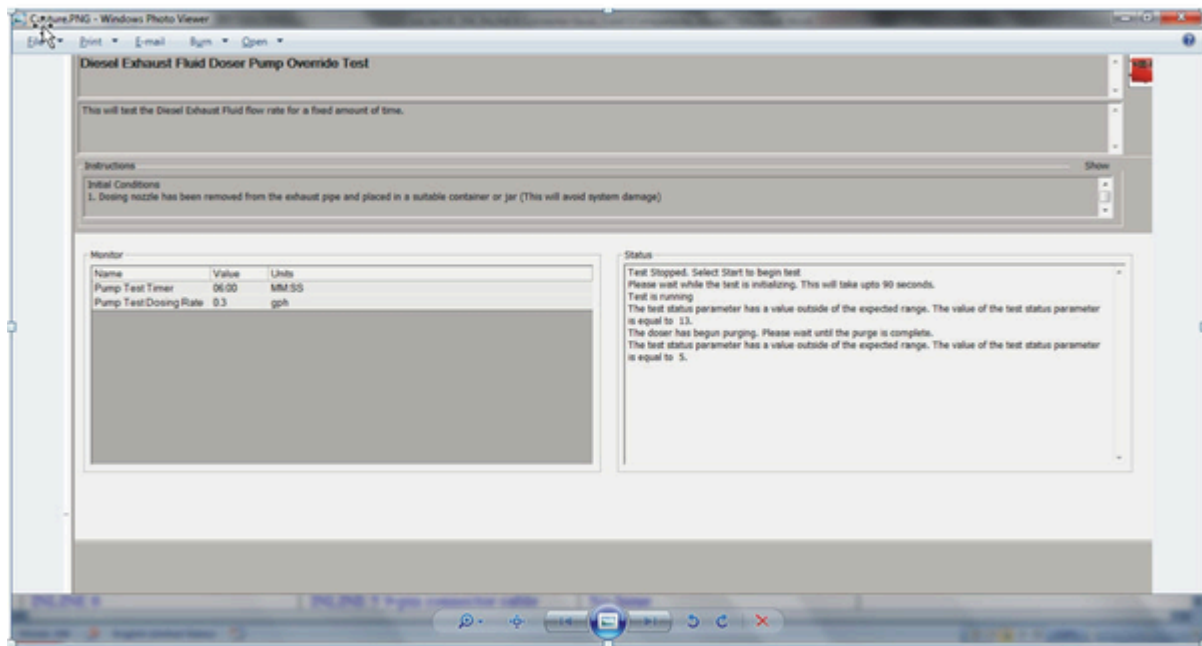
INSITE™ electronic service tool display

When running this test, INSITE™ electronic service tool could display the following:

"The test status parameter has a value outside of the expected range. The value of the test status parameter is equal to 13."

This will be displayed while the system is dosing. The test will automatically continue after dosing has completed. The issue is due to the fact that the engine control module (ECM) software supported this enumeration before it was requested in INSITE™ electronic service tool.

This message will be updated to "Please wait while the system is dosing." with the release of INSITE™ 8.0.1
