Technical Service Bulletin: TSB210206

Steel Lubricating Oil Pan Adapter Cover Cracks: Lubricating Oil Leaks

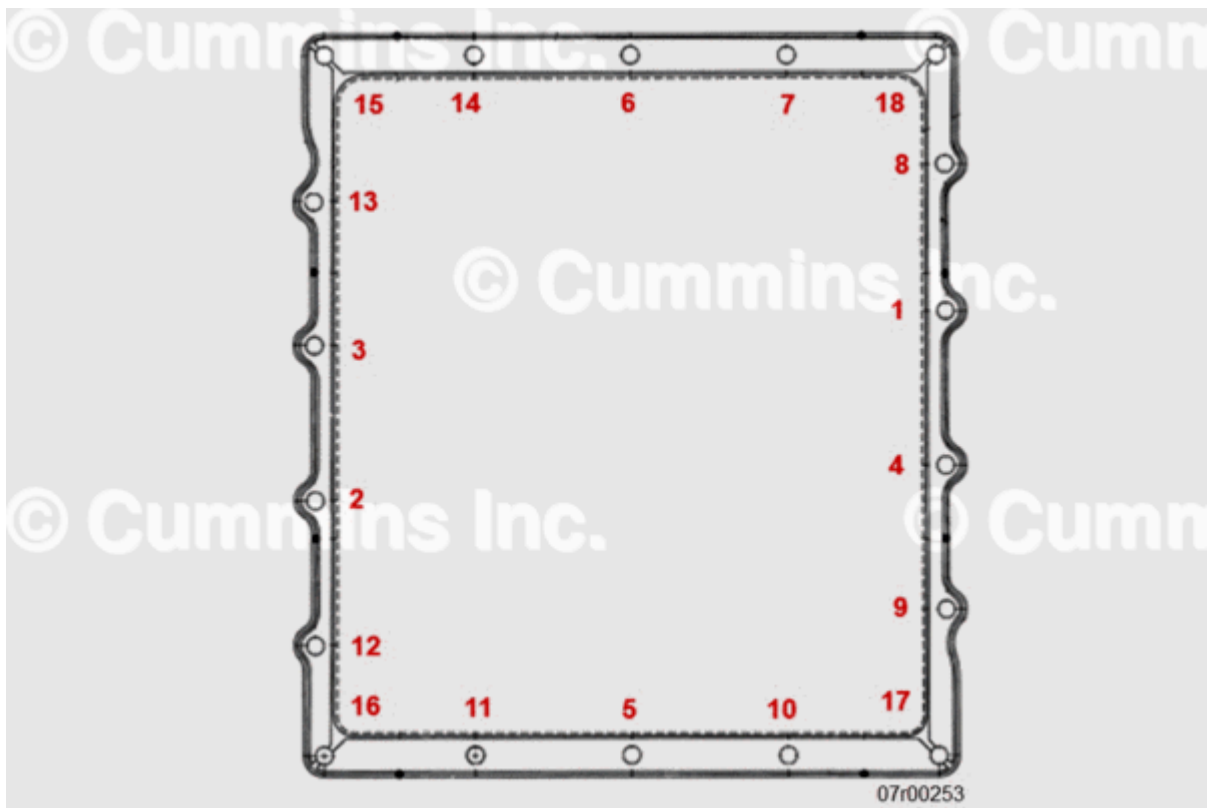
Image 4, Aluminum Lubricating Oil Pan Adapter Cover Torque Sequence.

- See Figure 3 below for a side by side comparison of each type of lubricating oil pan adapter cover.
- When using aluminum lubricating oil pan adapter cover, Part Number 207306, install the following:
 - New gasket, Part Number 3073213
 - Quantity 18 of new capscrew, Part Number 3035624. Torque to 47 N•m [35 lb-ft] using torque sequence in Figure 4 below
 - Quantity 1 of washer, Part Number 67946
 - Quantity 1 of threaded plug, Part Number 3055069. Torque to 54 N•m [40 lb-ft]
