Technical Service Bulletin: tsb090047	Released Date: 16-Jun-2009
Incorrectly Labeled Second Piston Rings

Incorrectly Labeled Second Piston Rings

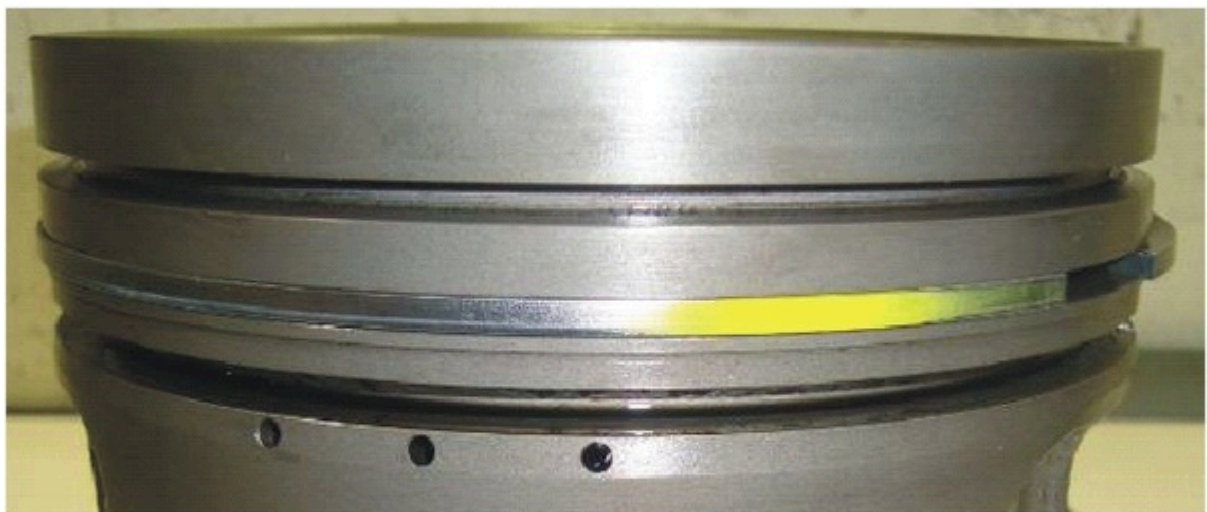
Figure 1, Piston Ring Part Number

Any piston ring labeled with Part Number 3090460 (see Figure 1 in the Repair Instructions) could be labeled incorrectly. Part sets or kits which include this ring in them are Part Numbers 4025115, 4025116, 4089247, 4089500, 4924652, 4924653, 4955790, 4955910, 4955975, and 4956091.
