Technical Service Bulletin: tsb100049	Released Date: 18-Jun-2010
Front and Rear Crankshaft Seal Leaks

Front and Rear Crankshaft Seal Leaks

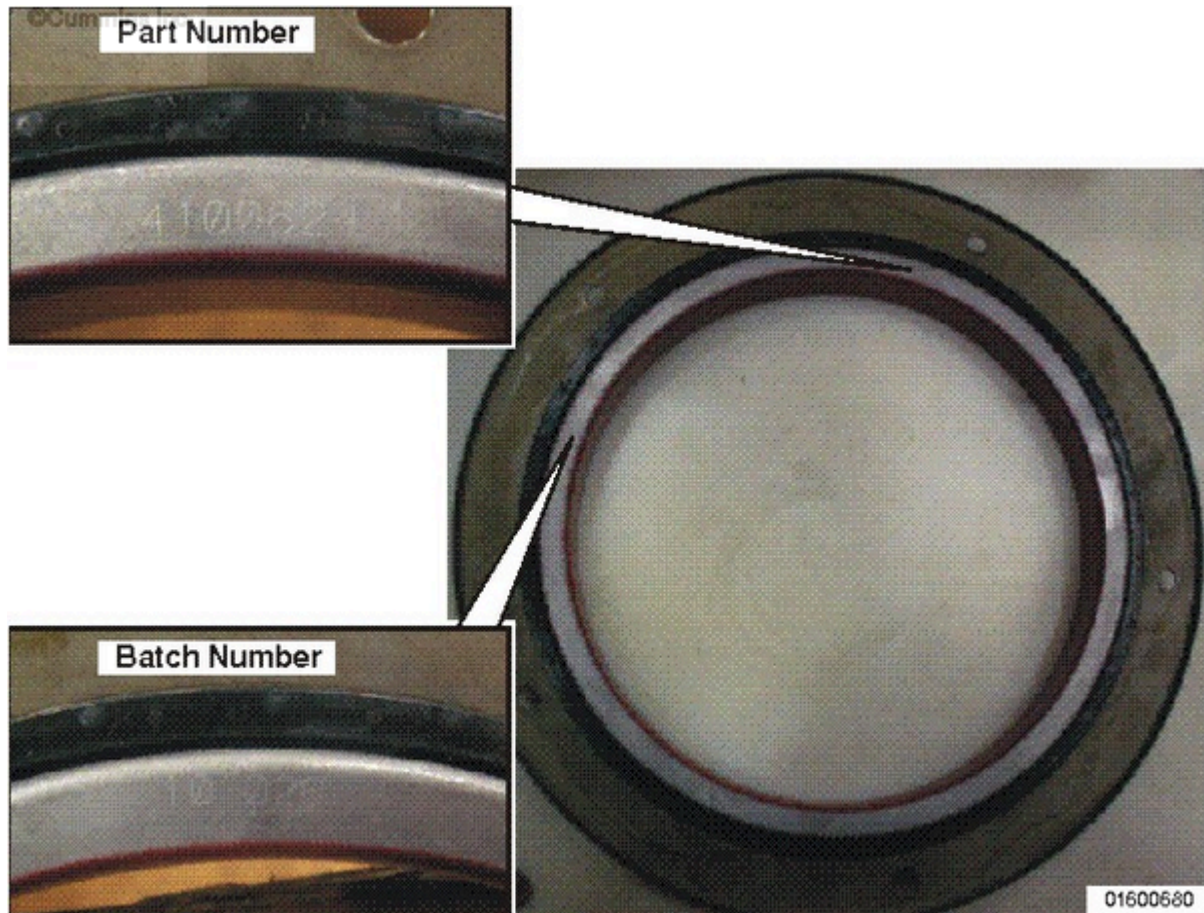
Location of Part Number and Batch Number on the Seal

There have been a number of front and rear crankshaft seal leaks on QSK45/60/78 engines in production test. The cause of the leak has been determined to be a manufacturing issue with the seal. The affected seals are from specific batch numbers. These numbers have been identified and are shown below. All seals with the batch numbers shown below **must** be removed from parts distribution centers (PDC) and distributor stock in order to prevent repeat malfunctions in the field. This issue was found during production testing and few, if any, seals were installed on production engines.

If a seal from one of the batches has been used on an engine, it may result in a low hour oil leak from the seal. **Only** seals that match the date codes below should be removed from stock.

The suspected cause of the seal leaks is a supplier quality issue, which has been corrected.

All stock of crankshaft seals **must** be checked against the batch numbers listed. If any seals match the batch numbers they **must** be removed from stock and **not** used.

Return the seals that match the batch numbers to PDC where they were purchased, referencing the Parts Alert Number 012-10.
