Technical Service Bulletin: tsb100281

Released Date: 19-Jul-2004

New Camshaft Bushing

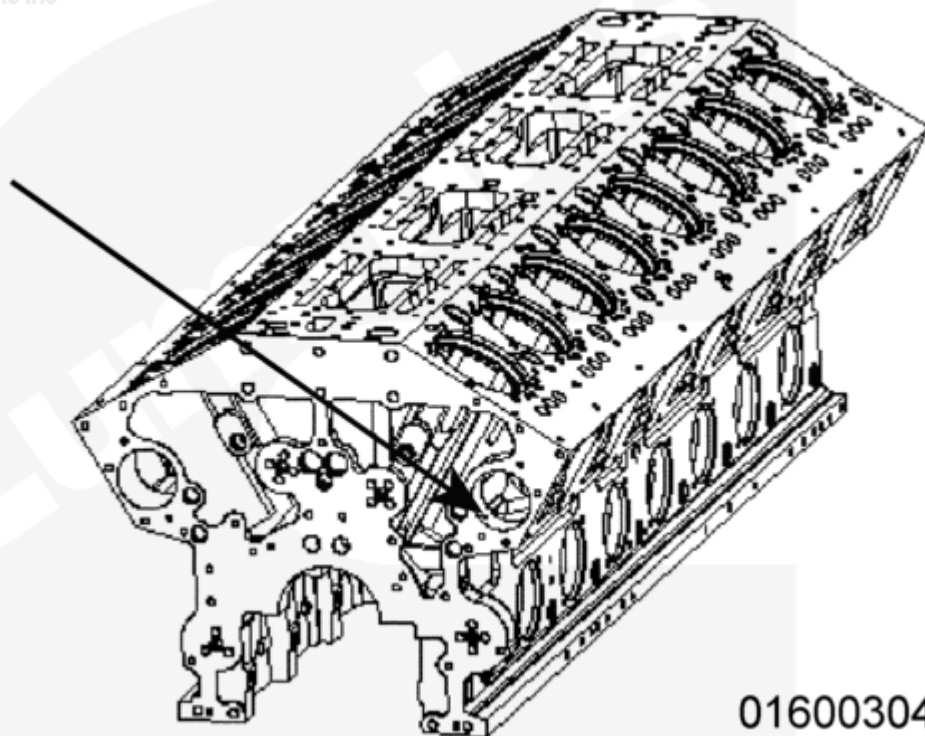
Figure 1 New Left Bank Front Camshaft Bushing, Part Number 4007741

Cummins Inc. recommends the new bushing be installed at rebuild or at any time all the camshaft bushings are replaced.

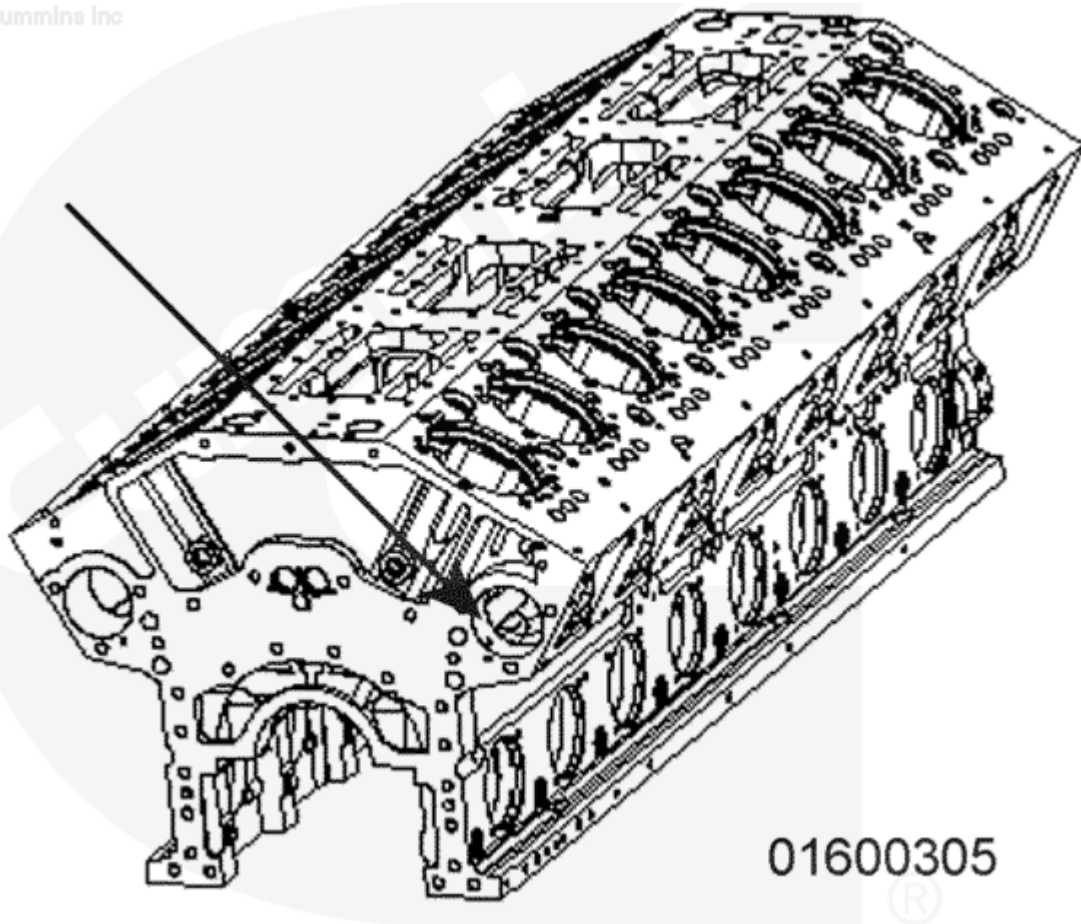
Figure 2 New Right Bank Rear Camshaft Bushing, Part Number 4007741
