Technical Service Bulletin: tsb100466

Released Date: 28-Apr-2006

Lubricating Oil Pump Idler Gear Assembly Kit

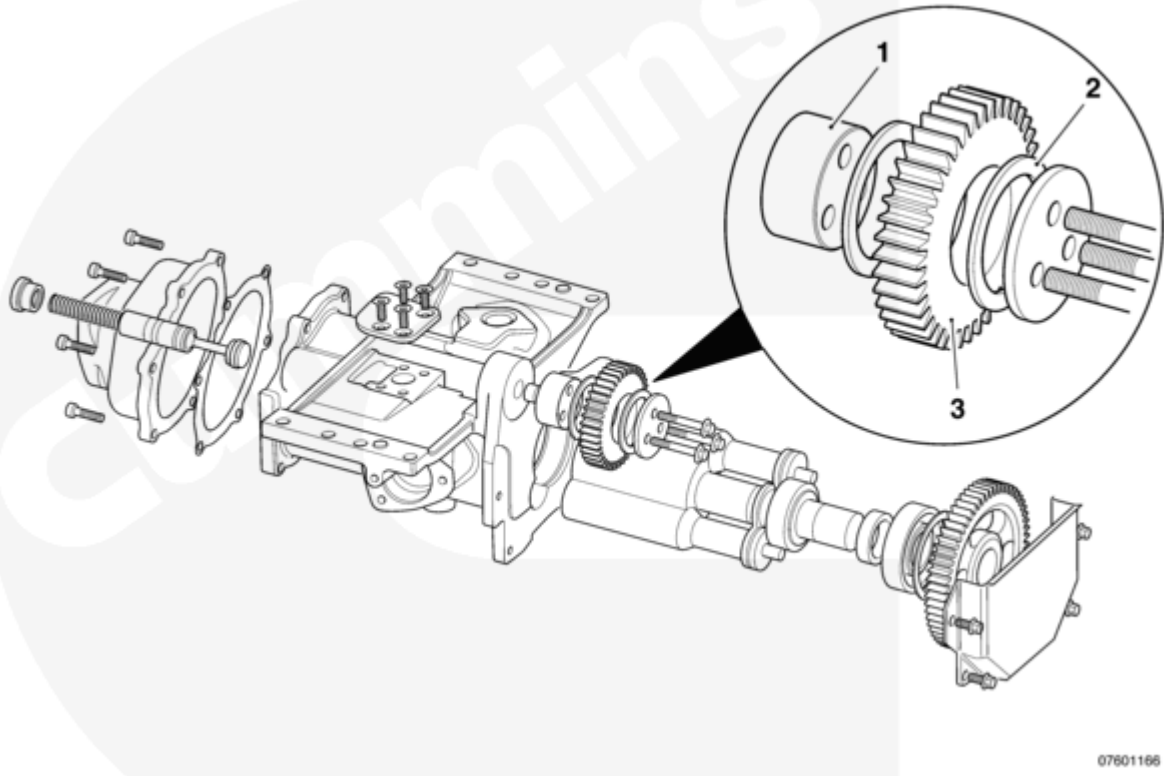
Lubrication Oil Pump Idler Kit, Part No. 4066547

It is important that people at the service and repair facilities are aware of this kit, since it is critical that these lubricating oil pump components are always in perfect operating condition. By design, this gear is lubricated by unfiltered engine oil, so it is therefore extremely susceptible to damage caused by metallic debris in the engine lubricating oil. Damage sustained to the components is likely to eventually lead to a complete failure of this mechanism and, consequently, to a total loss in lubricating oil pressure causing major engine damage.

Following any failure, by which the lubricating oil has possibly become contaminated with any form of metallic debris, the idler shaft and gear **must** be carefully inspected for the presence of any damage. If any damage is found, the component **must** be replaced.

The idler shaft, gear and thrust bearings are contained in the service kit.
