Technical Service Bulletin: tsb100721

Released Date: 30-Jul-2008

New LTA Water Pump

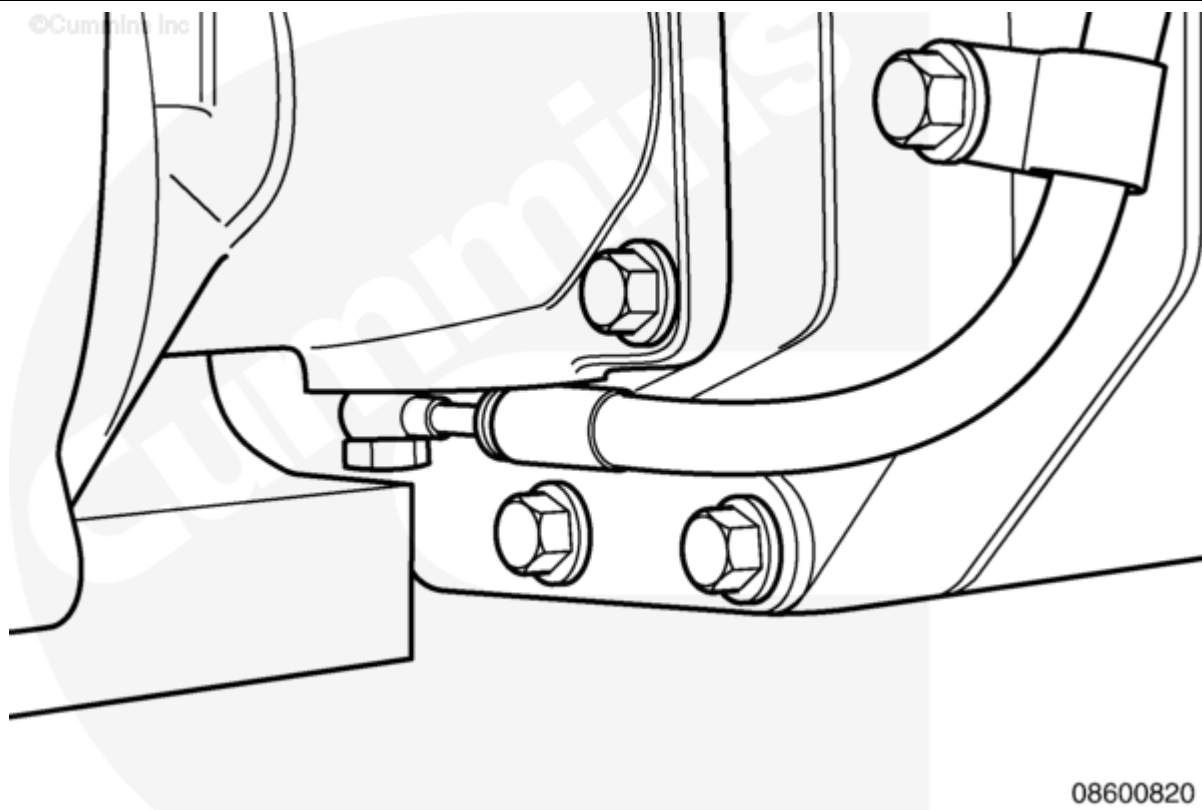
This Technical Service Bulletin introduces a revised LTA water pump, Part Number 3640492, and a new LTA water pump service kit, Part Number 4955807. The improvements include a change from a greased bearing to oil supplied bearings, which has increased lubrication. The oil feed is taken from the side of the gear cover.

The older style and revised LTA water pumps look similar in appearance, due to the primary improvements occurring internally. Reference Figure 1.

Figure 1, New oil feed.

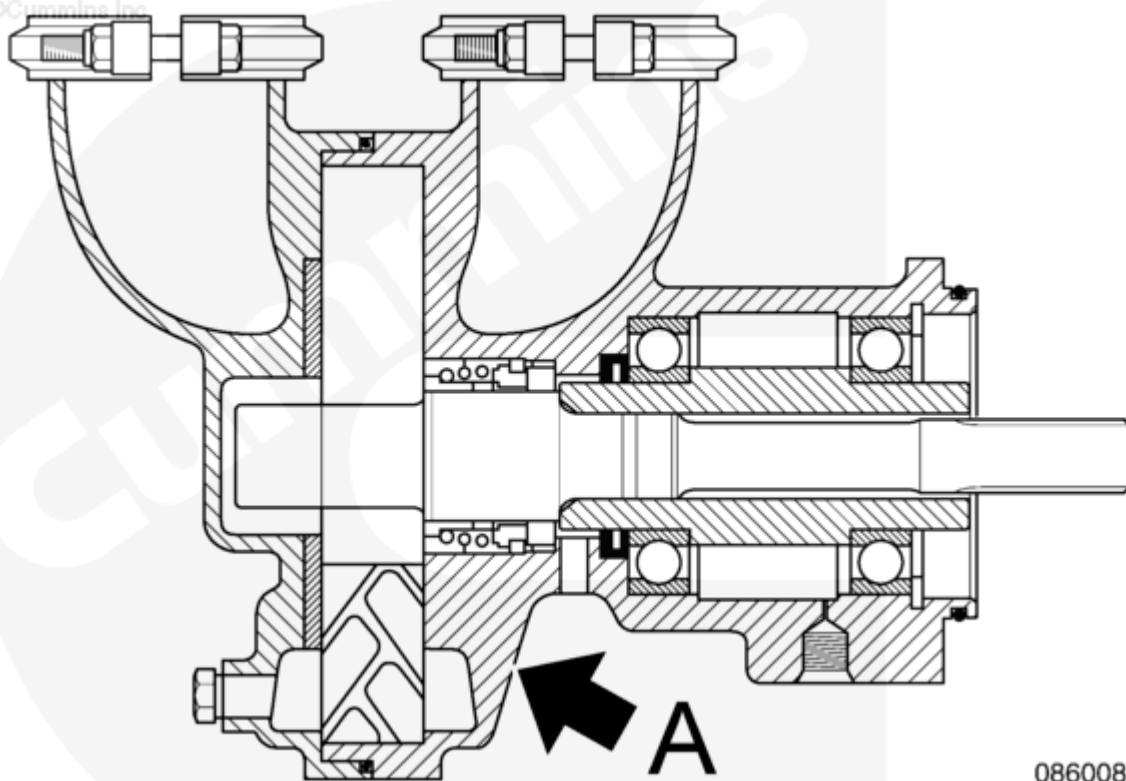
The strength of the water pump body has been improved by adding a stiffening rib, shown in the diagram below, and the introduction of a one-piece water pump body. Reference Figure 2.

Figure 2, Stiffening Rib (A).
