Technical Service Bulletin: tsb100822

Released Date: 07-May-2009

Eliminator™ Centrifuge Service Bushing

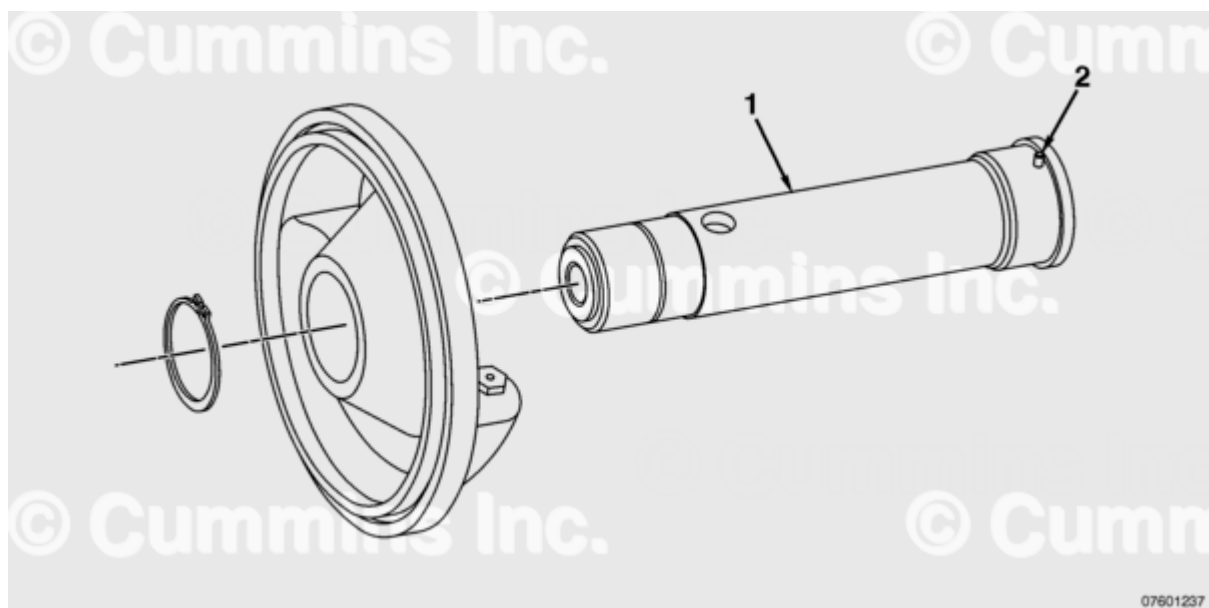
Excessive sludge or improper alignment can cause the bushing to become out of round. Be sure to clean the entire disk stack if there is excessive sludge in the centrifuge, to prevent future damage.

1. Service bushing
2. Alignment pin

This Technical Service Bulletin provides information on a service bushing for the Eliminator™ centrifuge. The service bushing, Part Number 3640564, can be used on QSK38/45/50/60/78 and KV38/50 engines. It can **not** be used on the QSK19 or K19 engines or on Fleetguard® centrifuges.
