Technical Service Bulletin: TSB101068

QSK45/60 Power Cylinder Replacer Service Tool Kit Rubber Casing Replacement

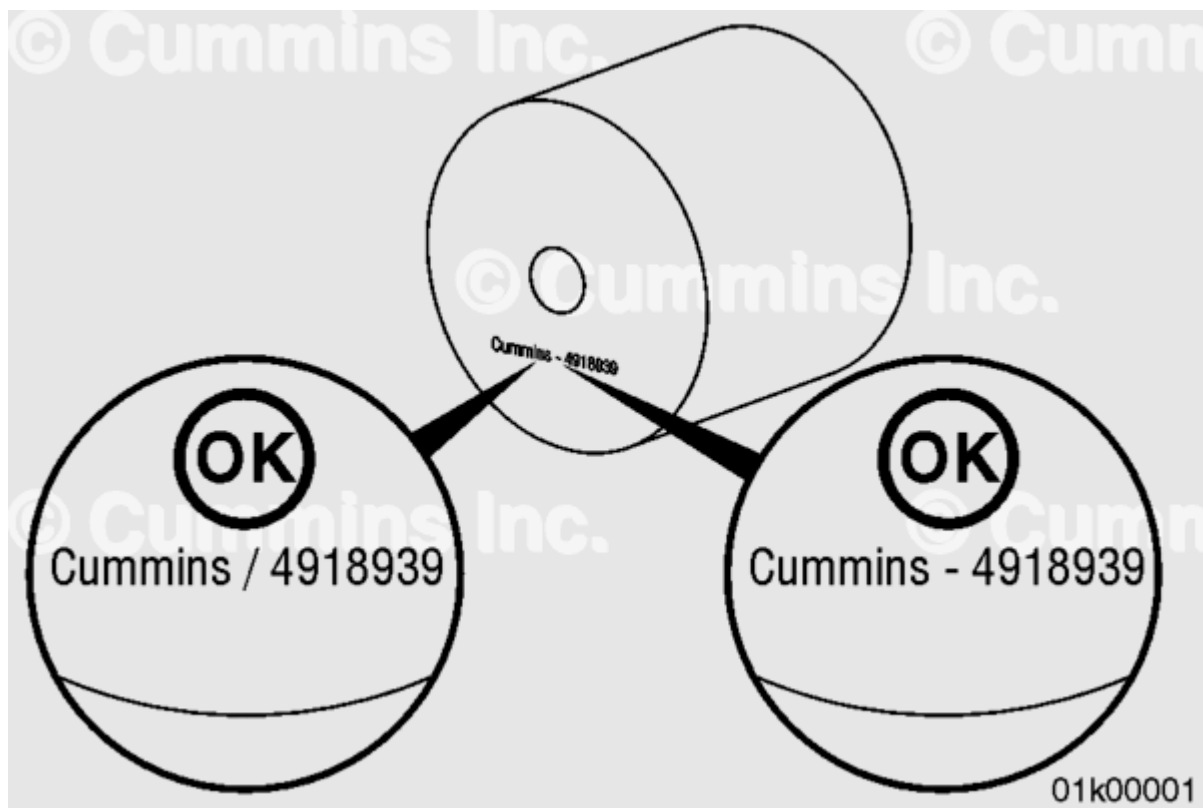
Correct Material

Rubber casings made from the correct material will have a forward slash marking or hyphen between the word Cummins® and the part number. The rubber casings that require replacement will **not** have this mark (see illustrations above). Each rubber casing returned is also eligible for replacement for the replacer plate, Part Number 4918944 (see instructions below).

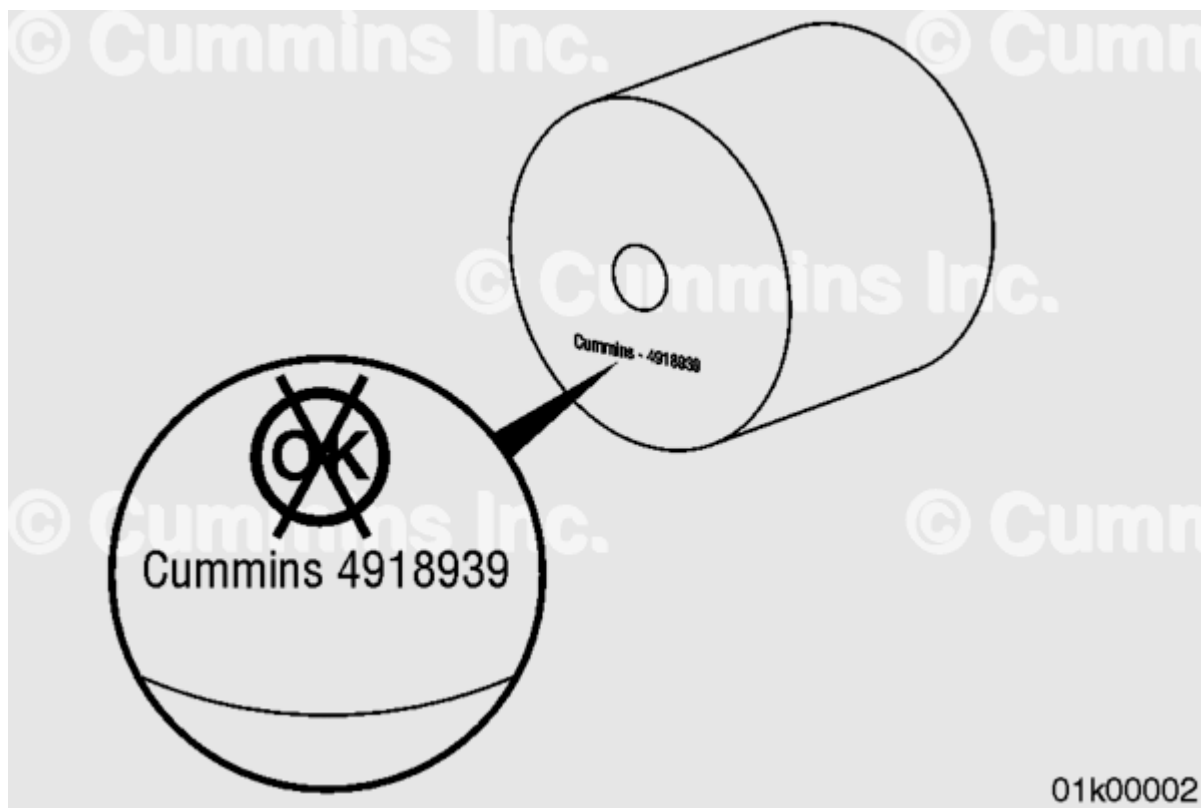
Incorrect Material

This document addresses the rubber casing, Part Number 4918939, supplied with the power cylinder replacer, Part Number 4919227, (also used in Part Number 4918985 and Part Number 4918950) that was manufactured using the incorrect material. Replacements for the rubber casing, Part Number 4918939, will be provided to customers that purchased power cylinder replacer, Part Number 4919227, cylinder liner replacer, Part Number 4918985, rubber casing, Part Number 4918939, and/or power cylinder replacer, Part Number 4918950. In addition, it has been determined the replacer plate, Part Number 4918944, can permanently deflect under recommended torque loads. A new replacer plate, Part Number 2892303, has obsoleted and superseded the replacer plate, Part Number 4918944, and will be provided to customers that purchased power cylinder replacer, Part Number 4919227, cylinder liner replacer, Part Number 4918985, and/or power cylinder replacer, Part Number 4918950.

If your rubber casing requires replacement, a warranty claim will need to be filed through the Service Products group against the rubber casing, Part Number 4918939, and the replacer plate, Part Number 4918944, **only**. Service Products will review the claim and process it for reimbursement. Once you receive reimbursement, an order may be placed for the new rubber casing, Part Number 4918939, and the replacer plate, Part Number 2892303.

Once the rubber casing is received by Service Products and confirmed to be the incorrect material, the warranty claim will be honored. The replacement rubber casing, Part Number 4918939, and replacer plate, Part Number 2892303, can then be ordered. Year 2010 pricing will apply to the order placed.
