Technical Service Bulletin: tsb101255

Intercooler Air Hose, Procedure 010-083

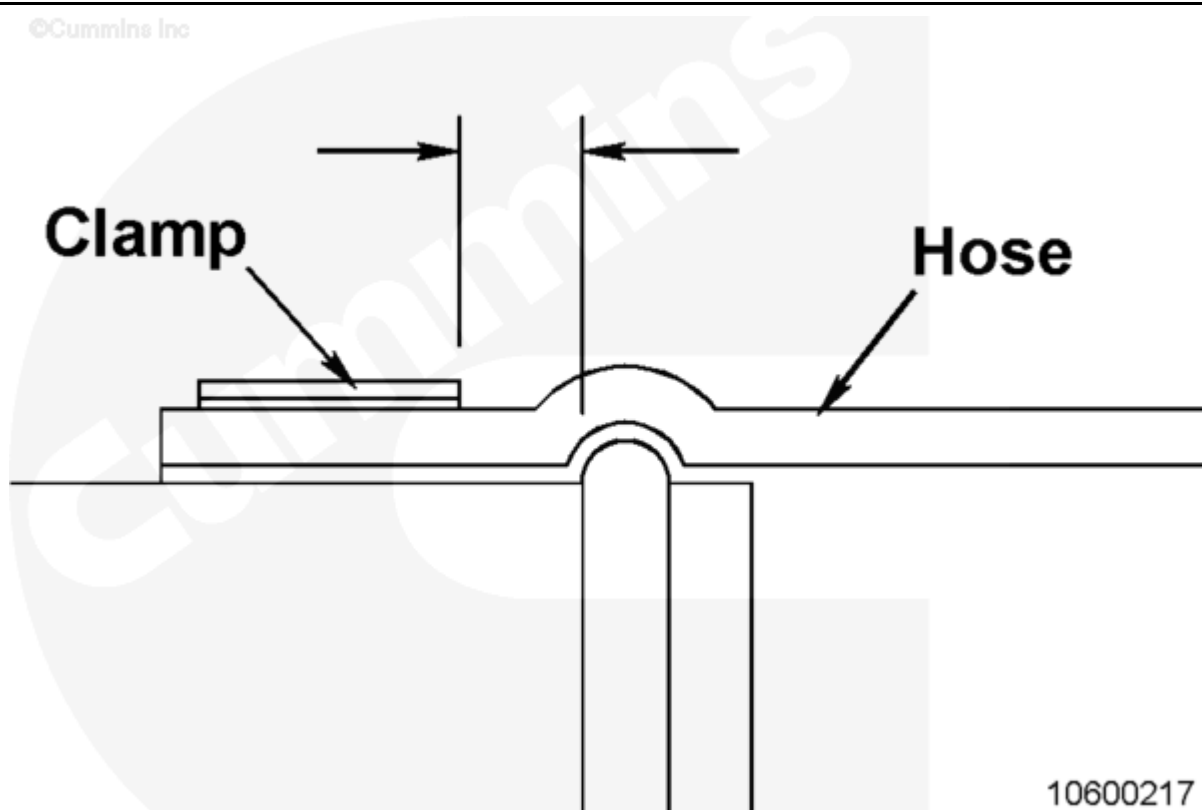
10600218

The cross section of the new hose, Part Number 4100590, has been increased to improve durability compared with the old hoses, Part Numbers 3067428 and 3171790. Part Number 4100590 can be used in place of both Part Numbers 3067428 and 3171790. The Daventry engine plant now uses Part Number 4100590 in all six locations.

Part Number 4100590 was introduced in plant with engine serial number first 33152841. The location of the hose is shown below.

The clamps **must** be positioned so the edge of the clamp is between 3 mm [0.125 in] and 6 mm [0.250 in] from the inner edge of the bead, as shown in the drawing above. Clamps **must not** overhang the edge of the hose. **Do not overtighten the clamps. Torque: 9 N·m [80 in-lb]**

This hose contains glass fibers. Installing the hose without first moving the intercooler, or forcing the hose into position will cause damage to the glass fibers and seriously reduce the working life of the hose.
