Technical Service Bulletin: TSB170095

Released Date: 08-Aug-2018

New Blowby Pressure Sensor

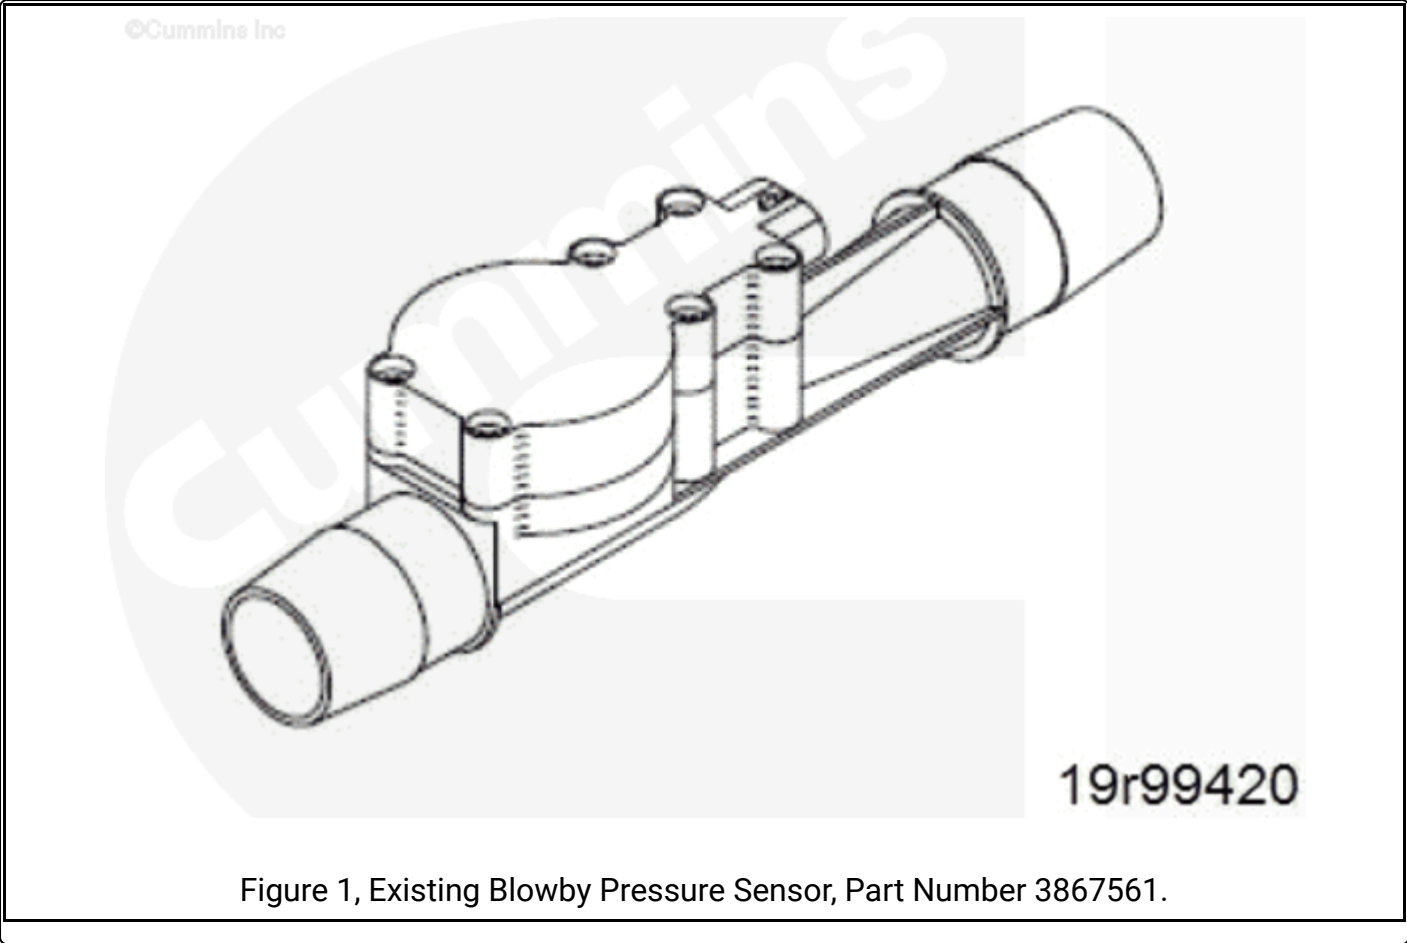
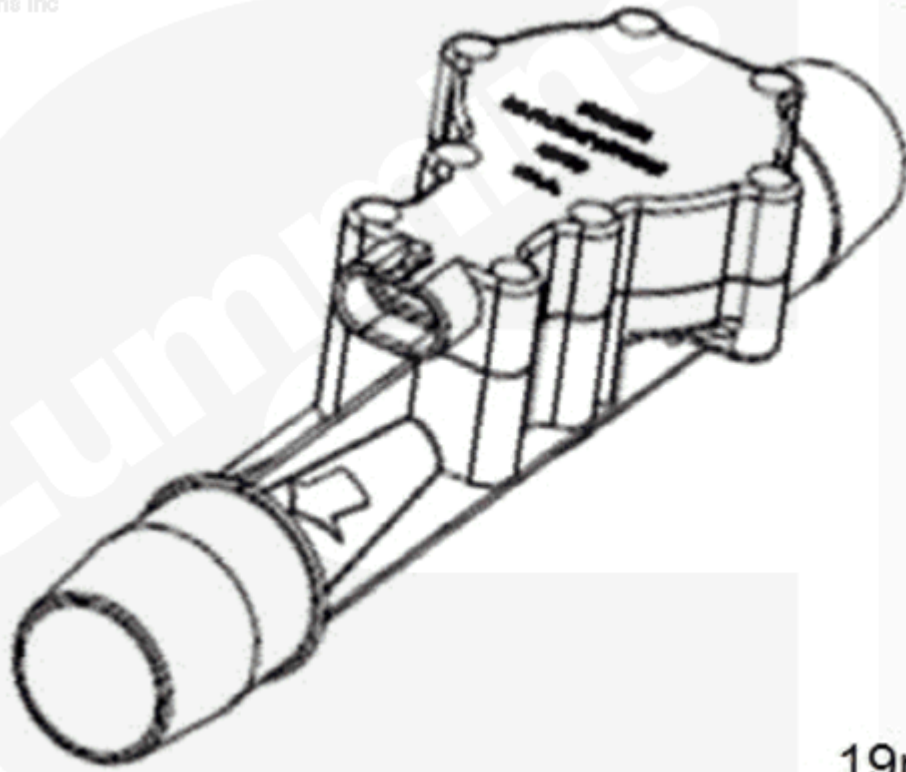
19r99421

- A new blowby pressure sensor is available. New blowby pressure sensor has a total of eight capscrews on upper housing of sensor body.
- Existing blowby pressure sensor has six capscrews on upper housing of sensor body.

Moisture or dirt ingress into sensor internals can occur as existing blowby pressure sensor has insufficient clamping of internal environmental and bezel seals. New design prevents loss of compression sealing on blowby pressure sensor upper housing.

New Blowby Pressure Sensor, Part Number 5461522.
