Technical Service Bulletin: TSB200223

Released Date: 28-Mar-2022

New Intercooler Transfer Tube Connection

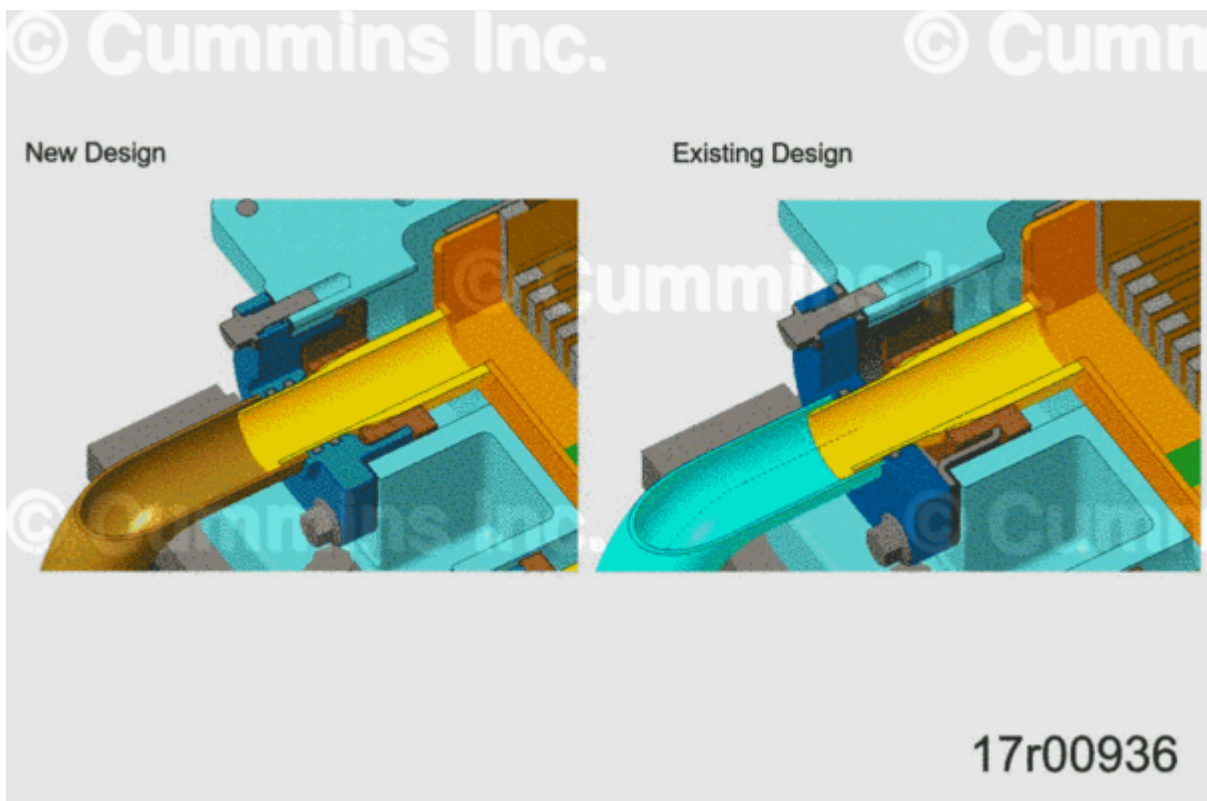
This TSB is to announce the new intercooler transfer tube connection with a Double O ring flange design. The new design includes the addition of a second O ring and an all in one water and air seal grommet. The Double O ring flange will hold the air seal.

The changes made to the flange design aim to improve contact area and sealing capability of the joint.

Figure 1, New Water Transfer Tube Versus Existing Water Transfer Tube

Figure 2, Cross Section of New Flange with Double O-Ring Groove.

Use of P80 lubrication, Part Number 3824878, during O ring installation is recommended for ease of assembly.

Use existing part number inventory before using the new part number.
