Technical Service Bulletin: TSB110029

QSKV Camshaft Stock Inspection

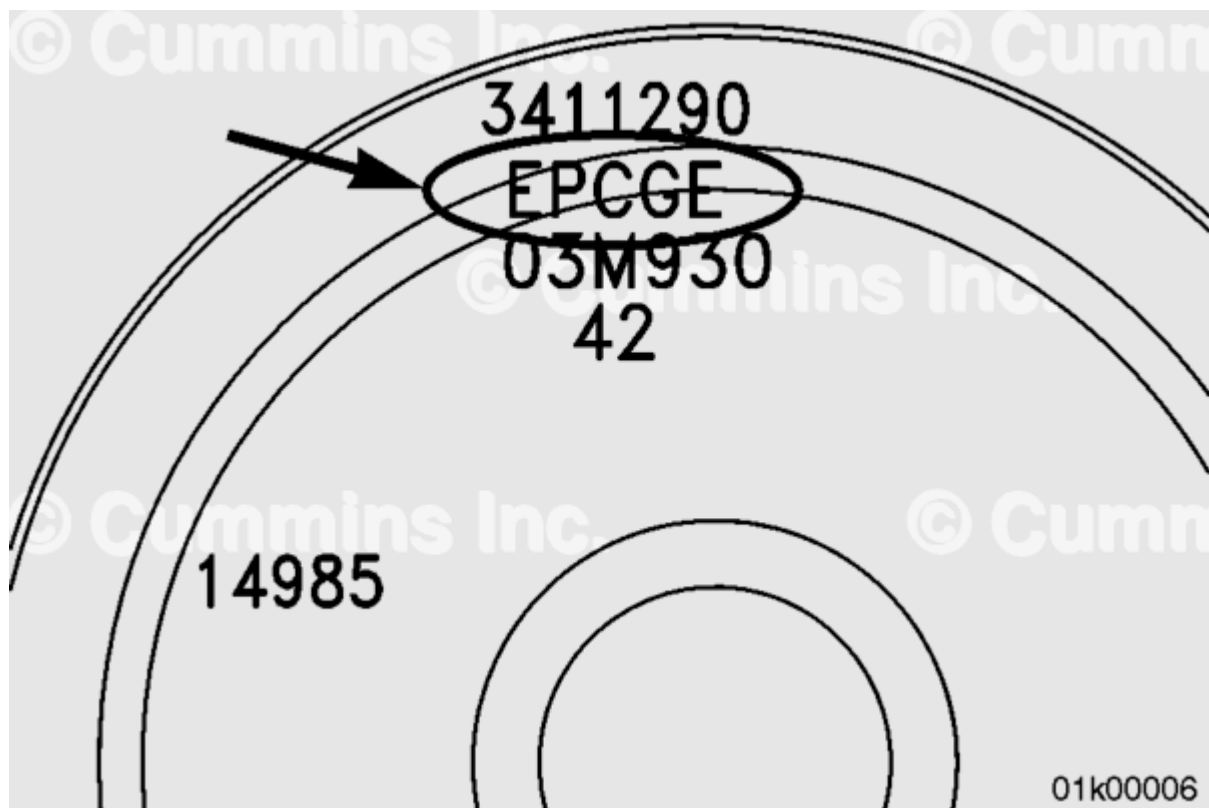
If the camshaft is stamped with the initials ATS and USA, no further action is required.

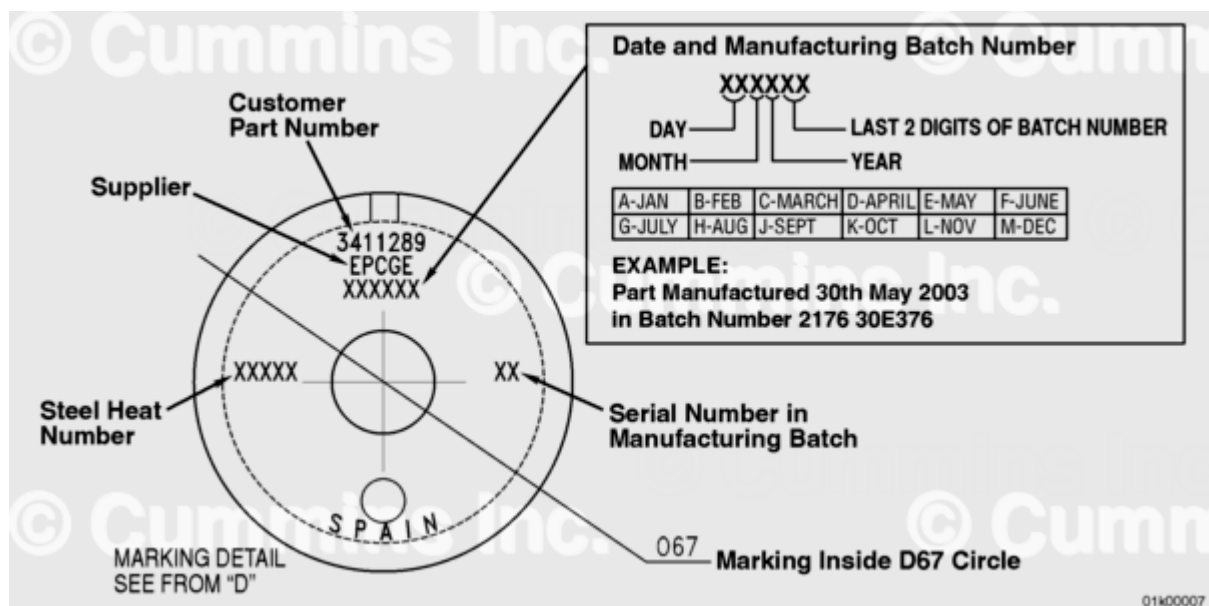
If the camshaft has been stamped with the initials EPCGE it is at risk and will need inspection.

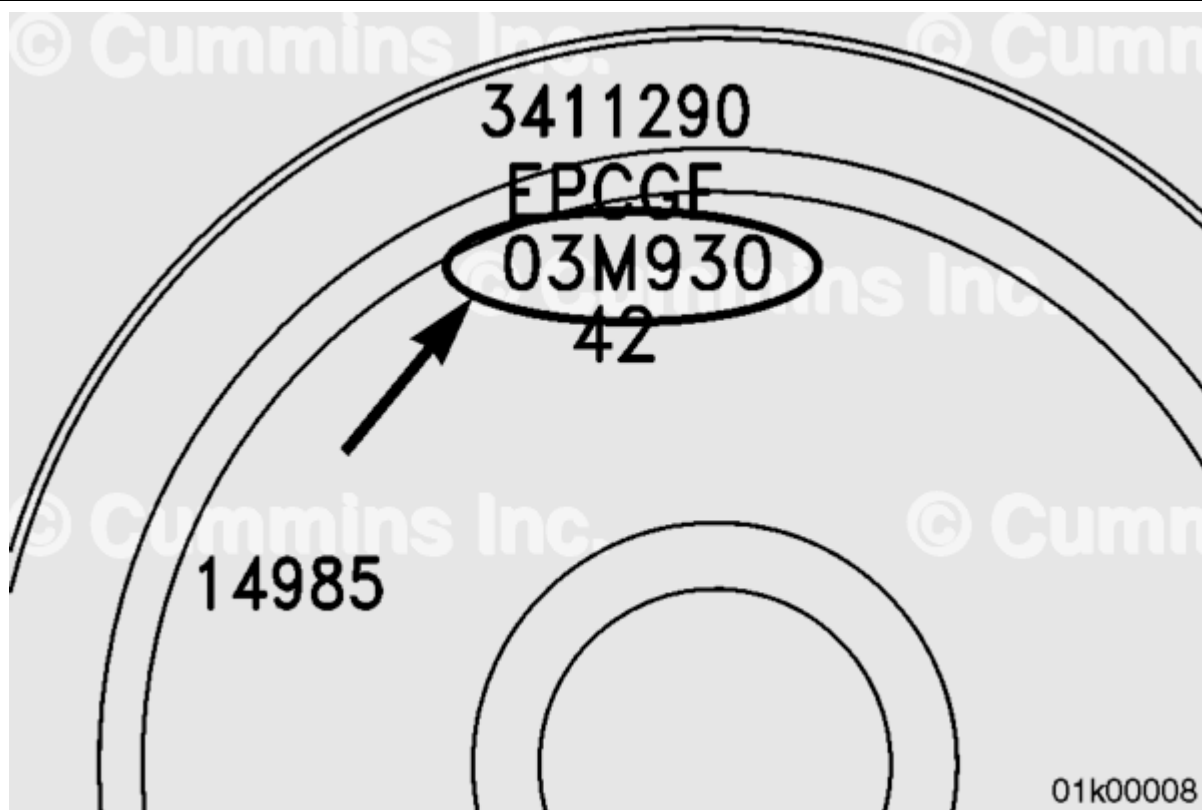
The illustration above is an example of a camshaft that was produced on 03M9 = 3-December-2009.

Produced before 10-November-2010 and therefore classified as "At Risk".

If the date code on an EPCGE camshaft is prior 10L0##, the camshaft was built prior to 10-November-2010, then contact the point of purchase and arrange for a return of the camshaft via a RGA (return goods authorization). The parts distribution center (PDC) will return parts to the supplier. The above illustration outlines the details on how the part date code is constructed and read.
