Technical Service Bulletin: TSB110086

Released Date: 24-Mar-2011

Identification of SAE J1939 Datalinks

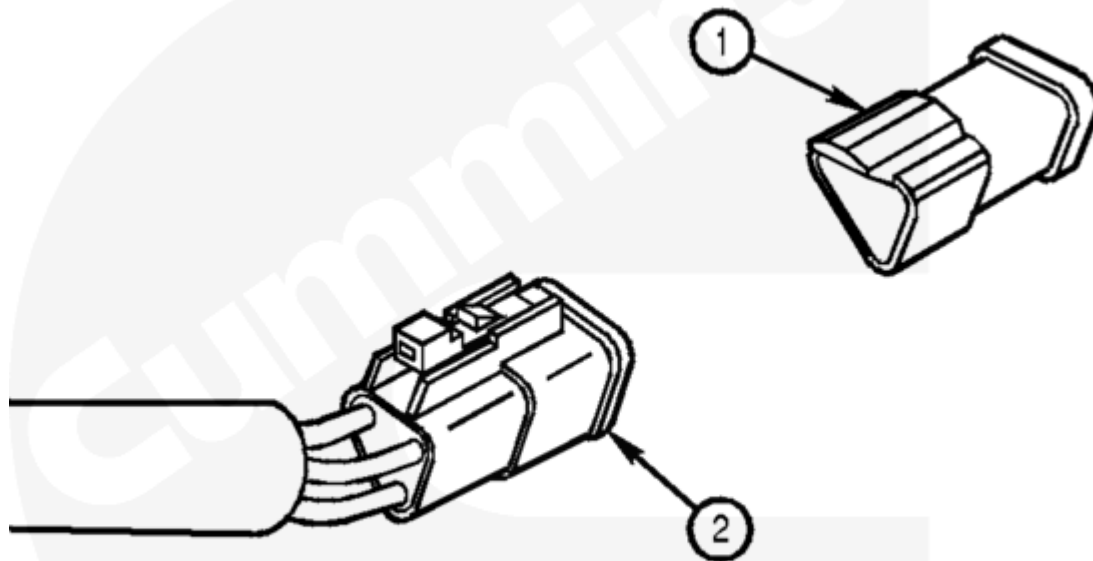
19802397

If the datalink is a plug (male connector), the resistance between pins A and B **must** to be measured.

If the resistance value is 60 ohms, the backbone is installed and the minibackbone cable is **not** needed.

If the resistance across the pins is greater than 100k ohms, a backbone has **not** been installed and cable, Part Number 3163597, is needed in addition to the minibackbone adapter cable, Part Number 3163096.

Note : Disconnect the 50-pin OEM harness from the engine ECM before performing the resistance check.

If the resistance across pins A and B is 120 ohms, one of the termination resistor caps (1) is missing in the OEM wiring harness plugs (2) and **must** be replaced for correct communication on the datalink.
