Technical Service Bulletin: TSB110116

Released Date: 28-Apr-2011

QSK78 New Generation Flexplate

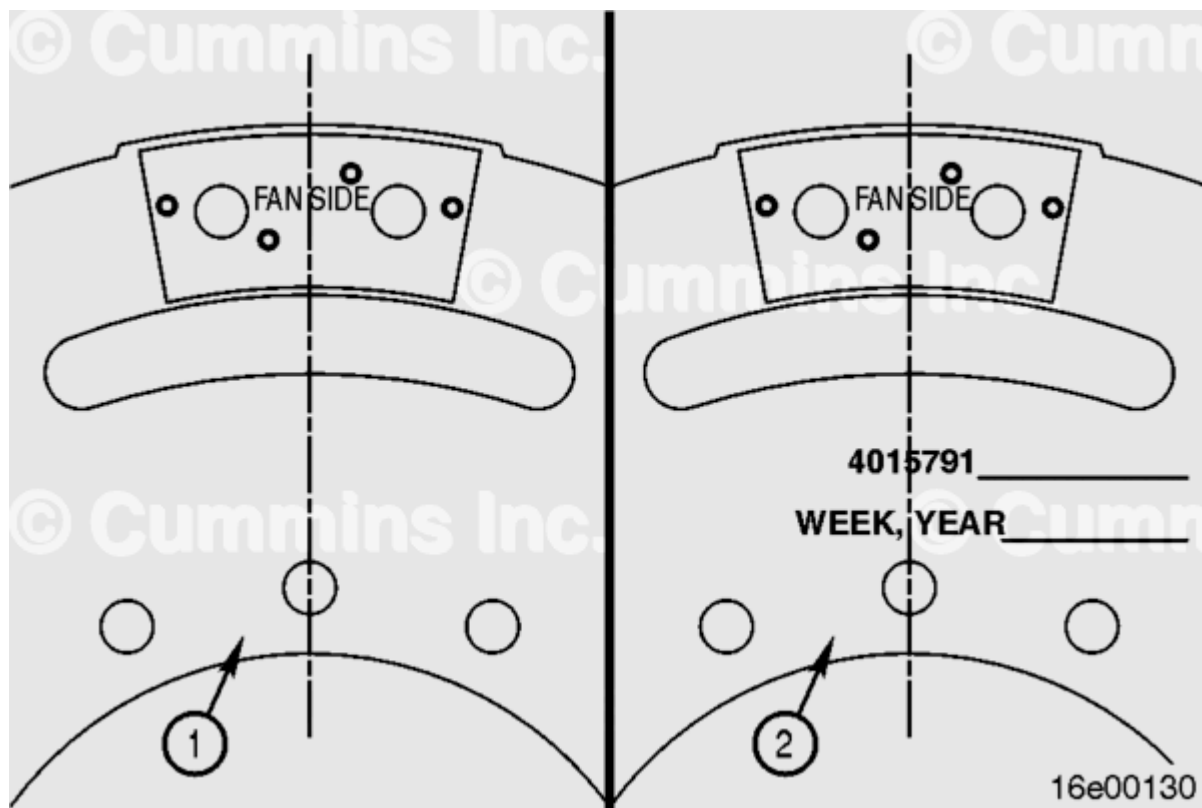
Old and New Generation Flexplates

1. Old Generation Flexplate - The **only** marking indicating "FAN SIDE" is stamped or etched close to the outer edge of the flexplate. There are no markings indicating part number and week/year of production.
2. New Generation Flexplate - The part number and production week/year are etched centrally under the stamped or etched marking indicating "FAN SIDE" which is located close to the outer edge of the flexplate.

Note : A correctly installed flexplate will have the "FAN SIDE" marking facing outward from the engine block, towards the generator fan.
