Technical Service Bulletin: TSB220146

New Fuel Pump Oil Supply Line

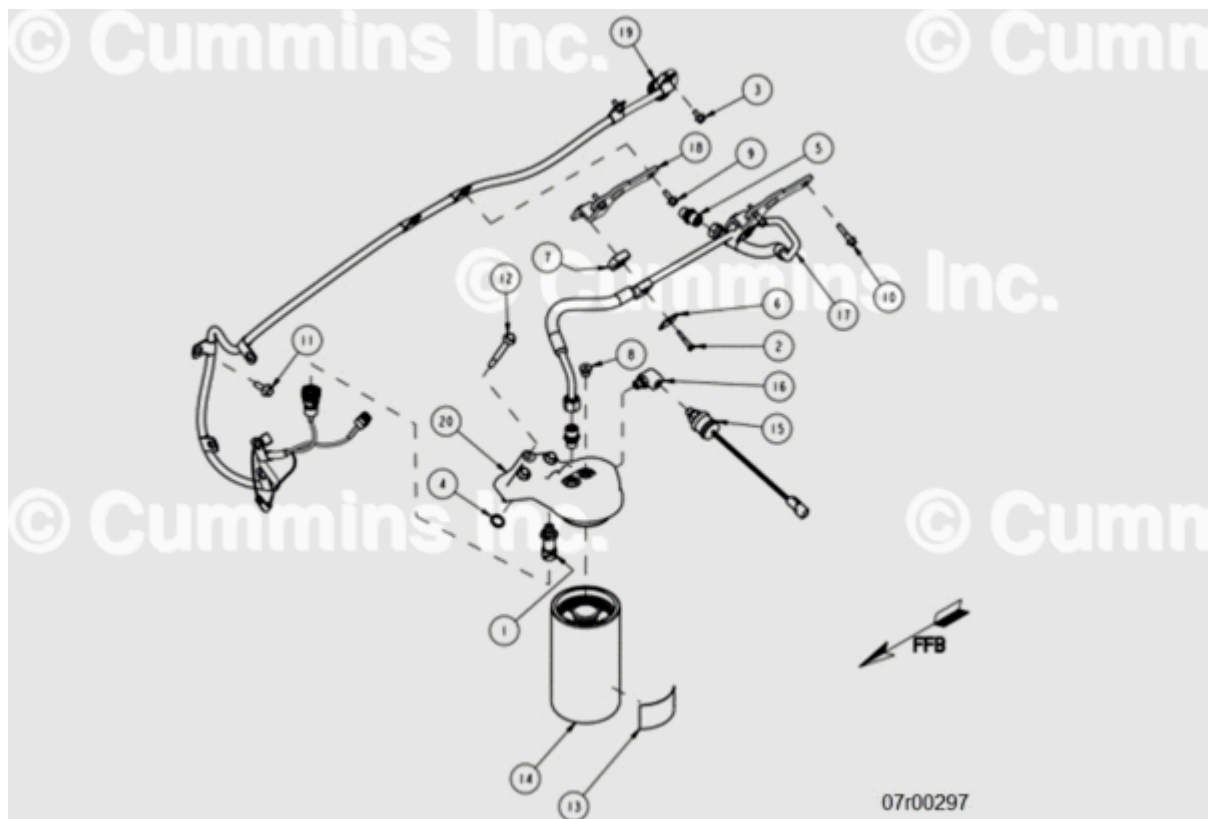
Figure 1, New Oil Supply Line Kit Parts Breakdown.

A new oil supply line has been developed for the modular common rail system fuel pump. The new oil supply line increases the oil pressure available to the fuel pump and improves the reliability and component life.

There have been reports of fuel pump fault codes relating to low oil and fuel pressure. To improve reliability, a new oil supply line has been released that increases the pressure of oil available to the fuel pump by feeding oil directly from the main oil rifle to the fuel pump accessory drive.

- Installation and removal instructions have been added to the Service Manual. See Publications Affected section below for details.
- These parts are **only** compatible with engines manufactured after 02 October 2020 or are utilizing a new cylinder block. See Part Compatibility section below.

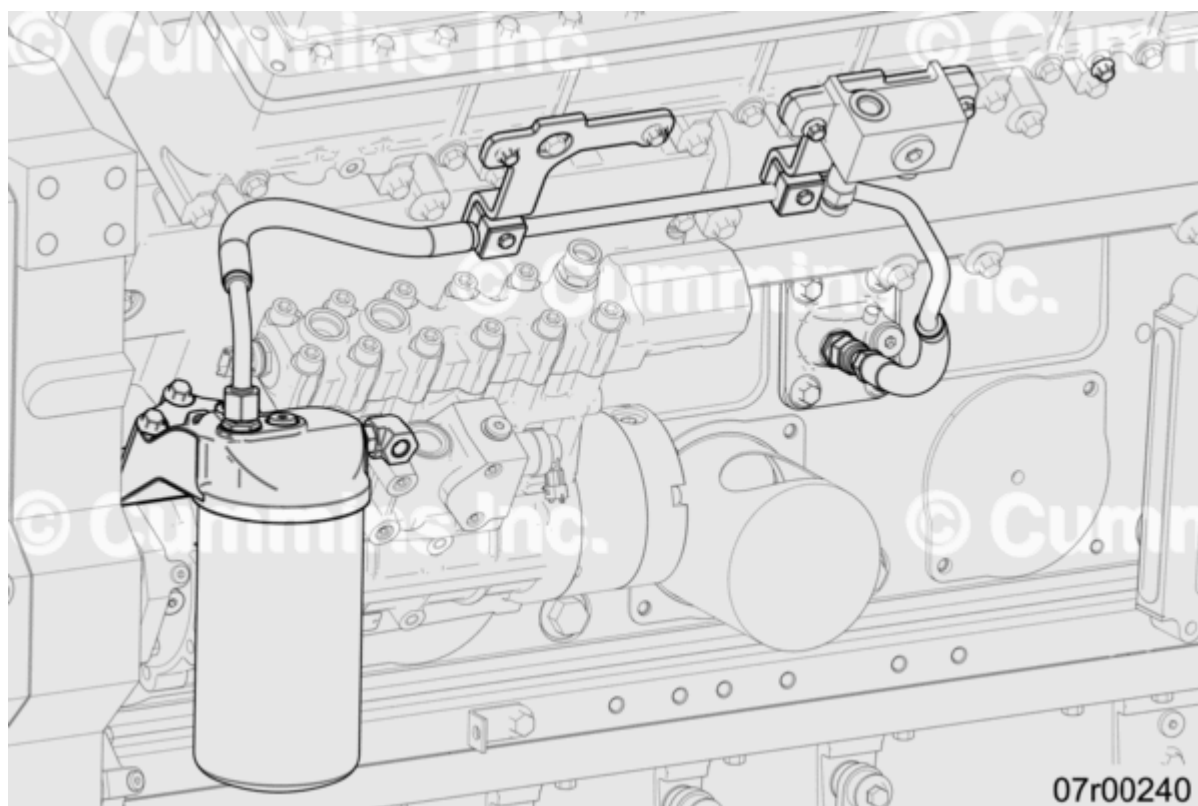
Figure 2, New Cylinder Block Supplied Oil Supply Line.

The new cylinder block supplied oil supply line can be identified by the supply point being a main oil rifle connection. See Figure 2 below.
