Technical Service Bulletin: tsb100362

Released Date: 03-May-2005

Fuel Line Bracket

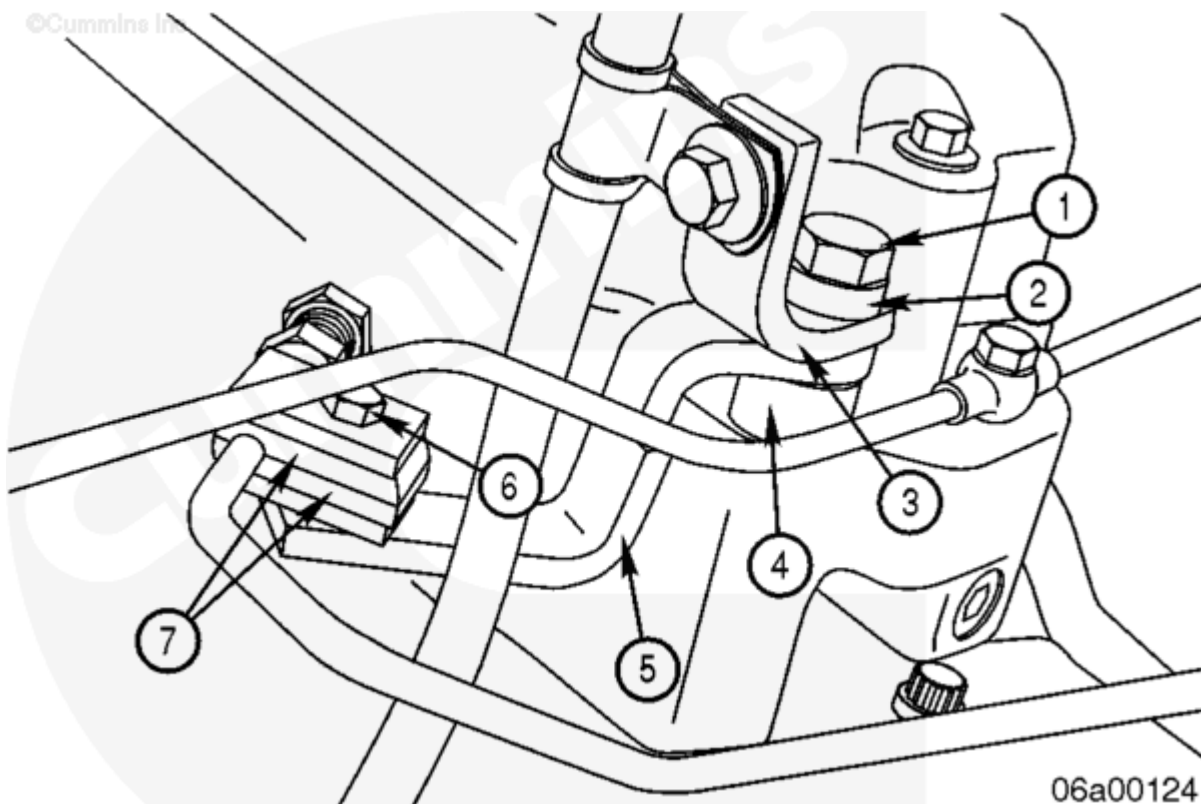
This Technical Service Bulletin announces an additional bracket to be placed on the right bank cylinder number 3 fuel line. Due to a large unbracketed span of the fuel line, the fuel line was able to vibrate and some have cracked due to high cycle fatigue.

The bracket components used have the same part numbers used on other fuel lines. No new components were needed or released. The parts will be added in production and are available to order for upfit.

The bracket components are listed below:

3094813	Capscrew, hexagon head flange (from rocker lever box location). This screw is replaced with part number 3093764.	1
---------	--	---
