Technical Service Bulletin: TSB200111

Eliminator™ Filter and Eliminator™ Hydraulic Motor

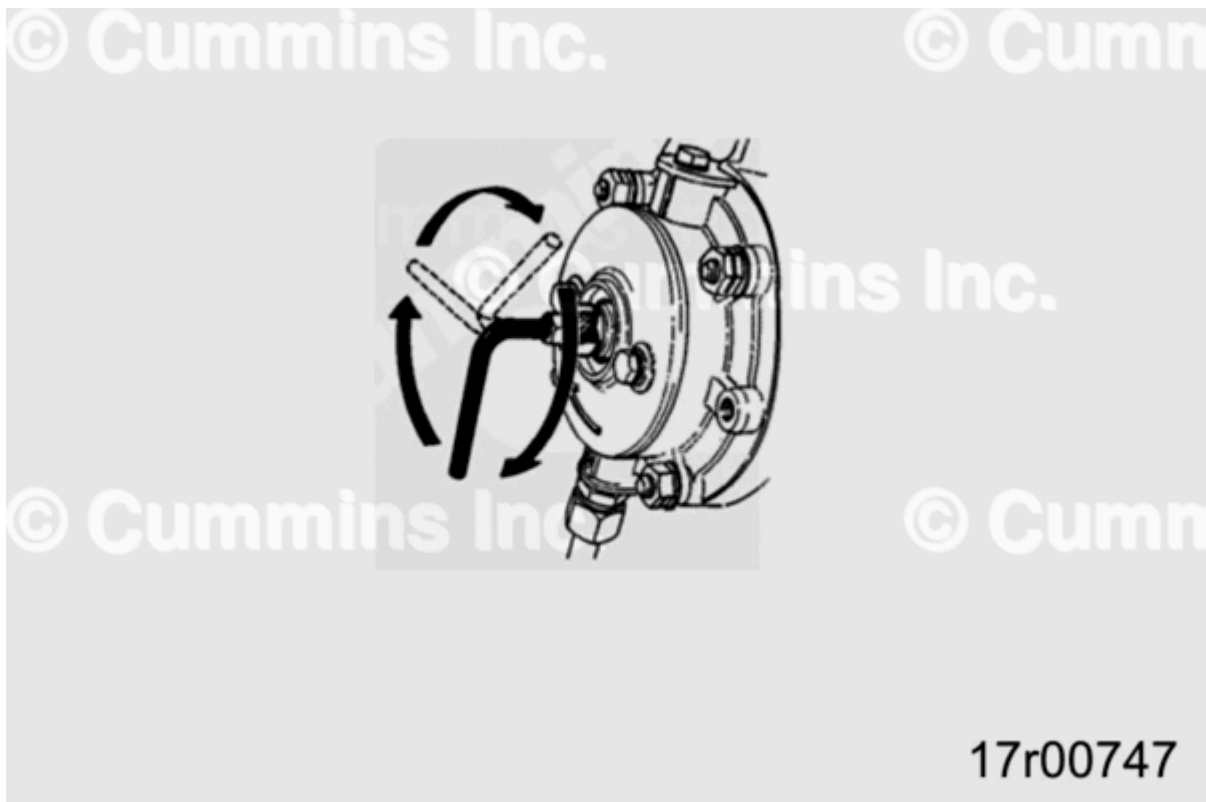
Figure 1, Hydraulic Motor

Symptom: No revolution or slow revolution of the hydraulic motor causing excessive residue to build up on the eliminator filter screens.

Root Cause: Oil leaks internal to the hydraulic motor causes motor to stop functioning as intended.

Check the function of the hydraulic motor. Make a note of the number of minutes it takes to do one revolution.

The following are given as a guide for a normal operating condition:

- Engine at idle: 10 minutes maximum

- Engine at max RPM: 5 minutes maximum

Note : If the operating indicator does **not** rotate, or the time for one revolution is more than indicated above, check the pressure drop and make a note of the value. Under normal operating conditions, the value **must not** exceed 12 psi.

If the motor is found to not function as intended, it **must** be replaced with a new or reconditioned part.

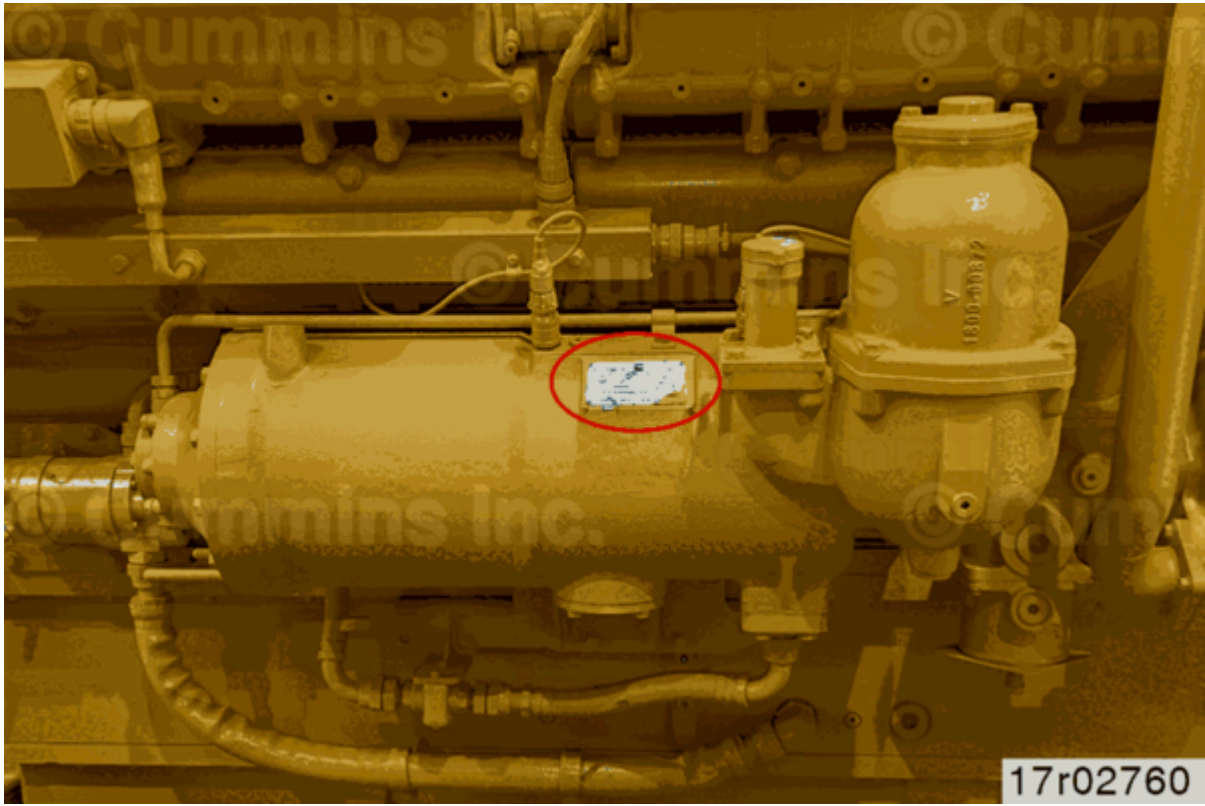
Figure 2, Eliminator Motor "CK" Marking Location (Previous version shown "CJ" for this example)

The two motors are only distinguishable by their stamped part numbers. The part numbers are marked on the motor and is their **only** identifier. The stamped designation "CK" identifies the latest part number motor. The "CK" stamping is only visible when the motor is removed. See Figure 2. The Cummins part number is not stamped onto the motor.
