Technical Service Bulletin: TSB210177

ReCon® Lubricating Oil Pump Engine Assembly Face Visual Difference

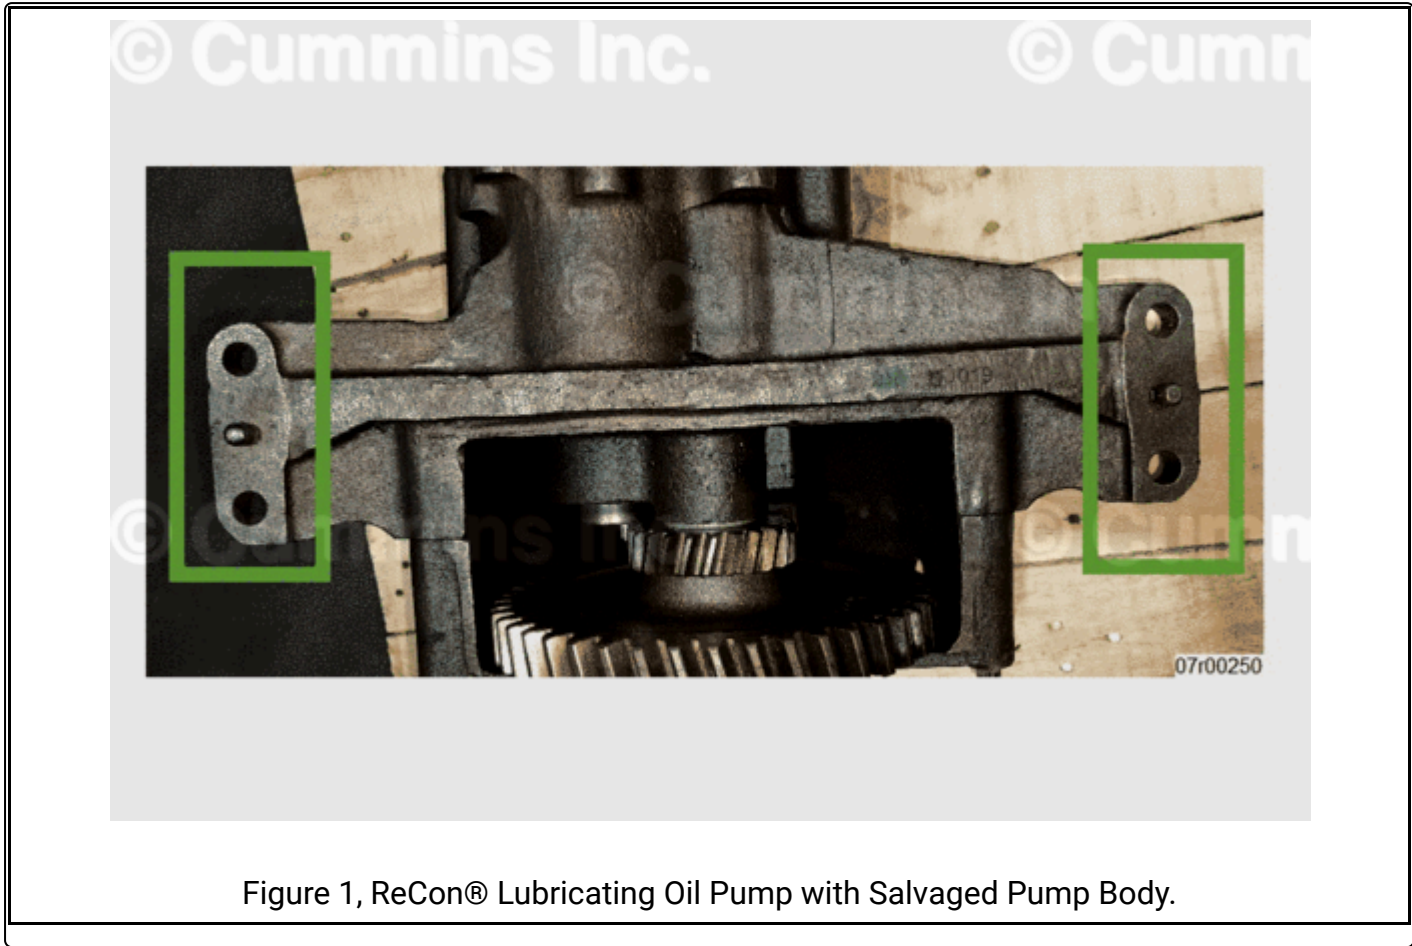
Some ReCon® lubricating oil pump engine assembly faces may have a rough surface.

- The ReCon® process is salvaging the lubricating oil pump body.
- ReCon® lubricating oil pumps will have rough surface on engine assembly face post salvage process. This surface roughness difference is acceptable. This roughness does **not** impact installation of lubricating oil pump and does **not** affect functionality of the lubricating oil pump.
