Technical Service Bulletin: TSB240023

Fuel Shutoff Valve: External Fuel Leak

- QST30 CM552

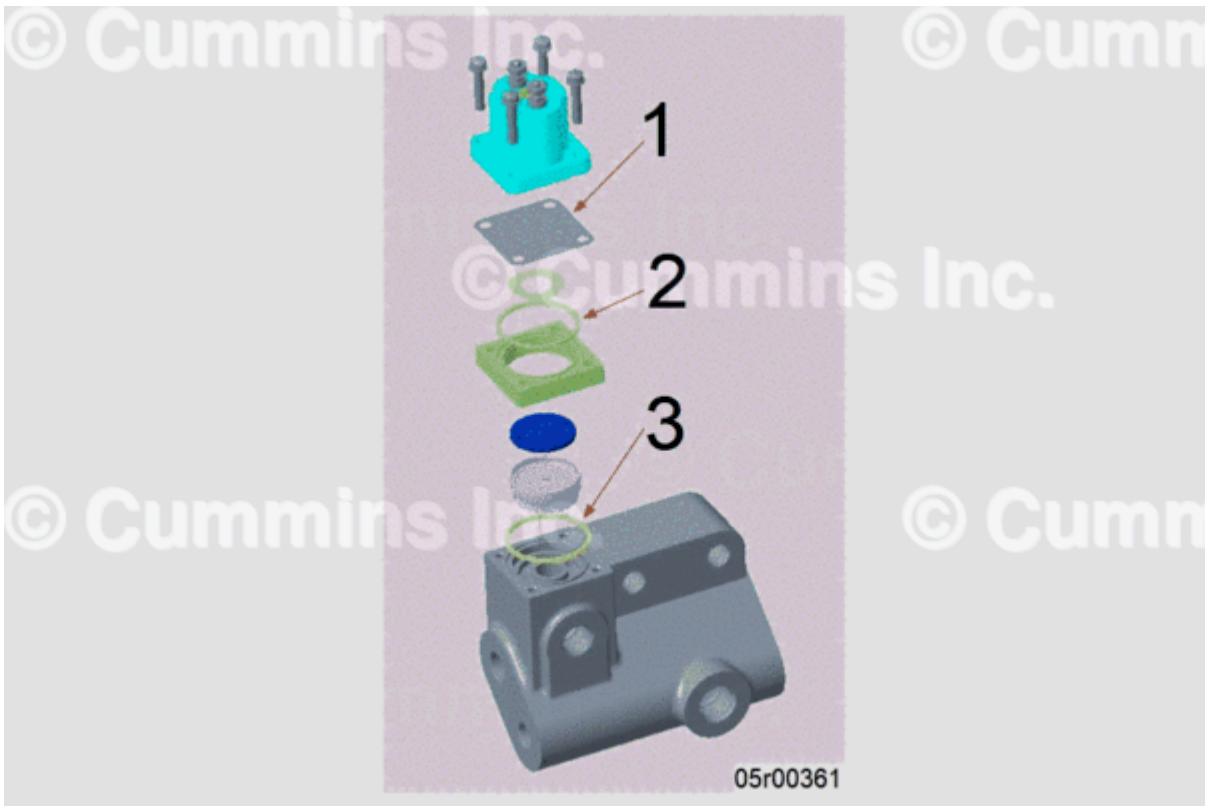
Figure 1, Exploded View of Fuel Shutoff Valve Assembly.

See QST30 Service Manual. Refer to Procedure 005-043 (</qs3/pubsys2/xml/en/procedures/57/57-005-043-tr.html>) in Section 5 for instructions on fuel shutoff valve disassembly and assembly. Figure 1 below identifies the fuel shutoff valve shield in the overall assembly.

- 1. Shutoff valve shield, Part Number 129839
- 2. Rectangular ring seal, Part Number 129888
- 3. Rectangular ring seal, Part Number 4975411

The fuel shutoff valve is a serviceable component. This malfunction can be repaired by replacing the fuel shutoff valve shield. See QST30 Service Manual. Refer to Procedure 005-043 (</qs3/pubsys2/xml/en/procedures/57/57-005-043-tr.html>) in Section 5 for replacement procedure.
