Technical Service Bulletin: TSB250112

Lubricating Oil Leaks from Turbocharger Compressor Outlet

- QST30 CM552

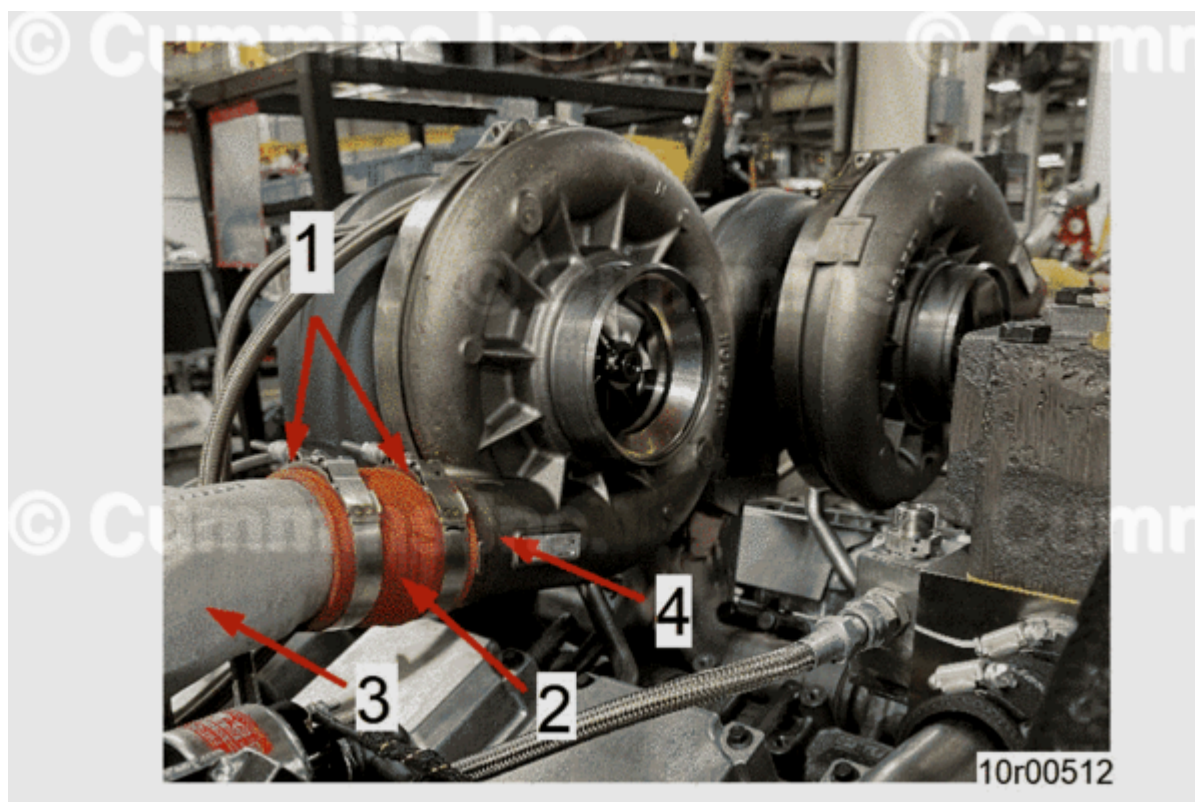
- With prolonged operation in low-load and low-speed conditions, lubricating oil can accumulate in the turbocharger bearing housing and leak past the turbocharger compressor seal, leaking externally at the air crossover hose connection between the turbocharger compressor outlet and air crossover inlet.

Figure 1, Example of Turbocharger Joint (LB shown).

- Loosen the T bolt clamps (1) on the air crossover hose (2).
- Refer to Procedure 010-019 (</qs3/pubsys2/xml/en/procedures/57/57-010-019-tr.html>) in Section 10 to remove the air crossover.

- Remove the T bolt clamps (1) from the air crossover hose (2) and remove the hose from the turbocharger compressor outlet (4).
- Clean the outer surfaces of the air crossover inlet (3) and turbocharger compressor outlet (4).
- Clean the inner surface of the air crossover hose (2).
- Apply a bead of Loctite RTV Gasket Maker: SI 587, Part Number 135504, or equivalent, to the outer surface of the air crossover inlet (3) and the turbocharger compressor outlet (4) behind the lip of the inlet/outlet.
- Install the air crossover hose (2) onto the turbocharger compressor outlet (4).
- Loosely install the T bolt clamps (1) onto the hose (2).
- Refer to Procedure 010-019 (/qs3/pubsys2/xml/en/procedures/57/57-010-019-tr.html) in Section 10 to install the air crossover (3).
